GUIDANCE NOTES
GD 21-2019

INTERNATIONAL SHIP CLASSIFICATION

**SURVEY GUIDELINES FOR OIL
TANKERS IN SERVICE**

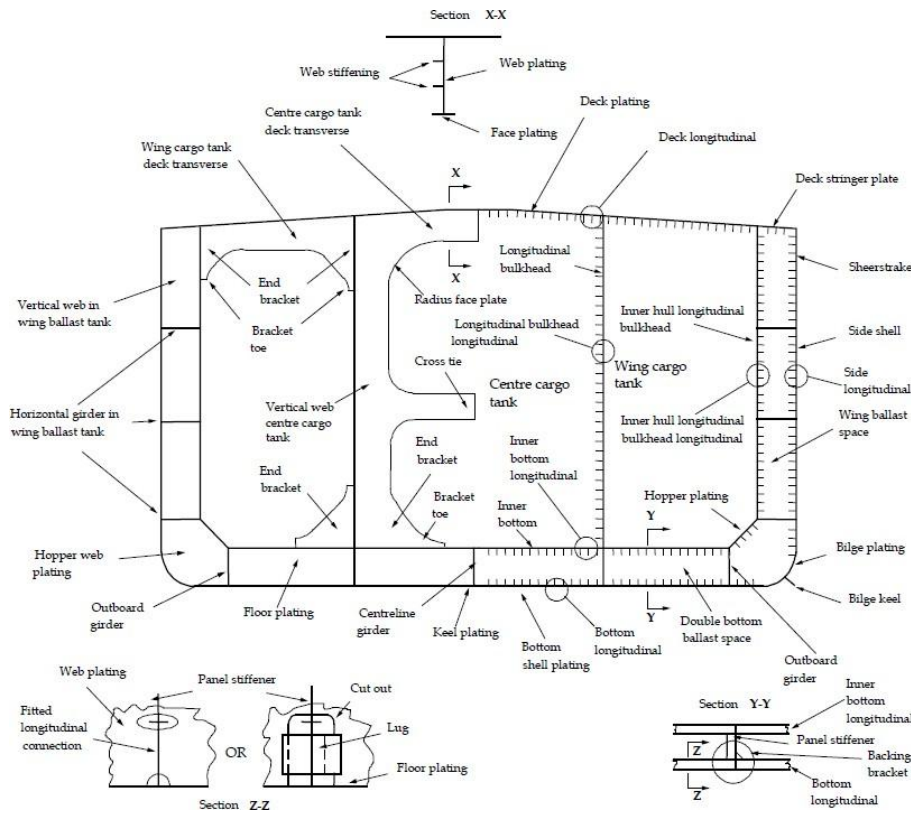
(2) Typical midship section of a double hull oil tanker with transverse bulkheads including nomenclature is shown in the figure below:

Figure 1.3.2.3 (2) Typical transverse section of a double hull oil tanker including nomenclature

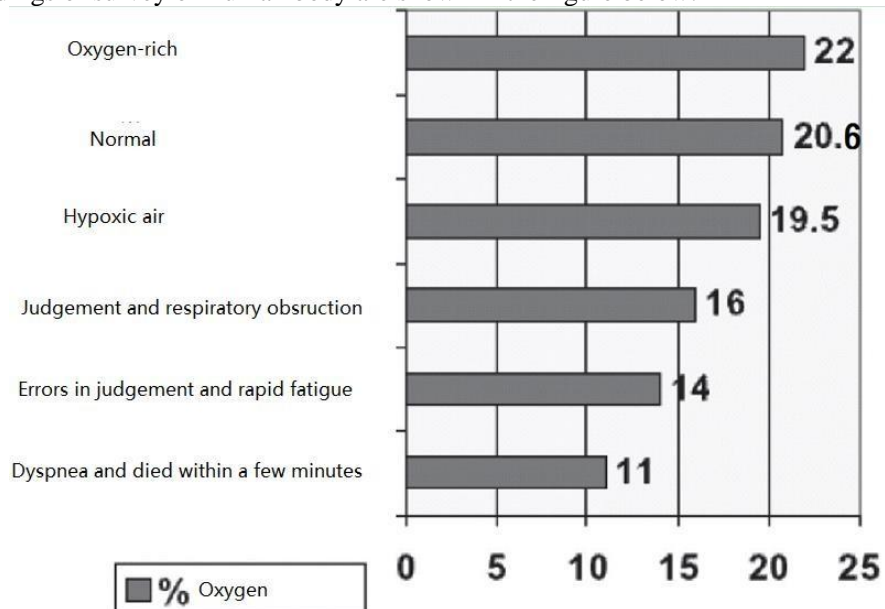
2.1.2.1 Before entering enclosed spaces to carry out inspection, it is to be confirmed that relevant spaces have been fully ventilated. Continuous mechanical ventilation is to be arranged during survey. Prior to survey, it is to be confirmed that O₂ content of relevant tanks has been tested to meet intended requirements. The members of survey group are to carry personal oxygen analyzers and stop survey when alarm occurs or being uncomfortable. The impacts of oxygen content in the surroundings of survey on human body are shown in the figure below:

Figure 2.1.2.1 Impacts of different oxygen contents

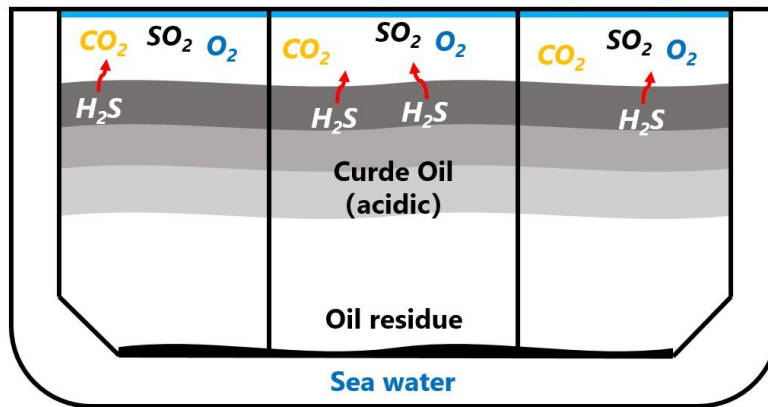
The corrosion rate of structure under deck is about 0.1 mm per year
Dry/wet alternation due to temperature change of day and night

Pitting corrosion rate of inner bottom plating is about 1.5~2.5mm per year

Figure 4.1.2.5(6)①a Corrosion rate of structure under deck and inner bottom plating

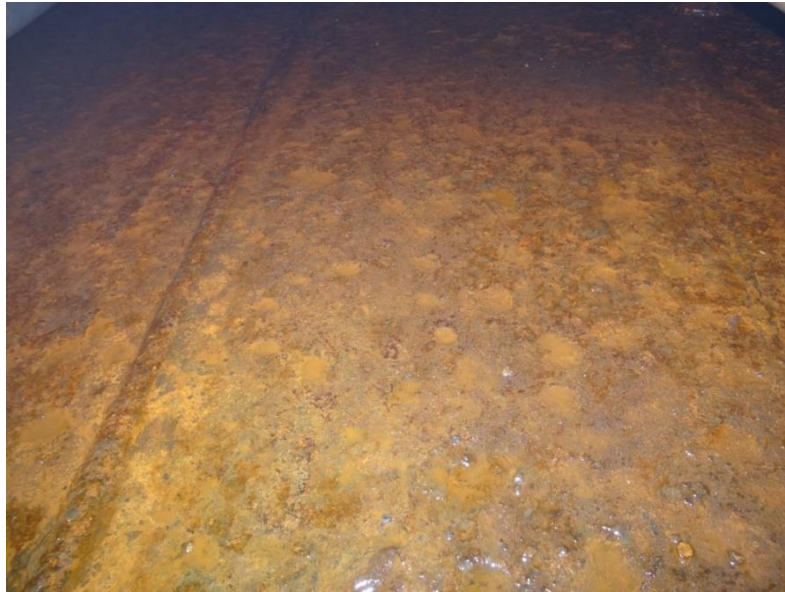
Figure 4.1.2.5(6)①b Typical pitting corrosion of inner bottom plating in cargo oil tank

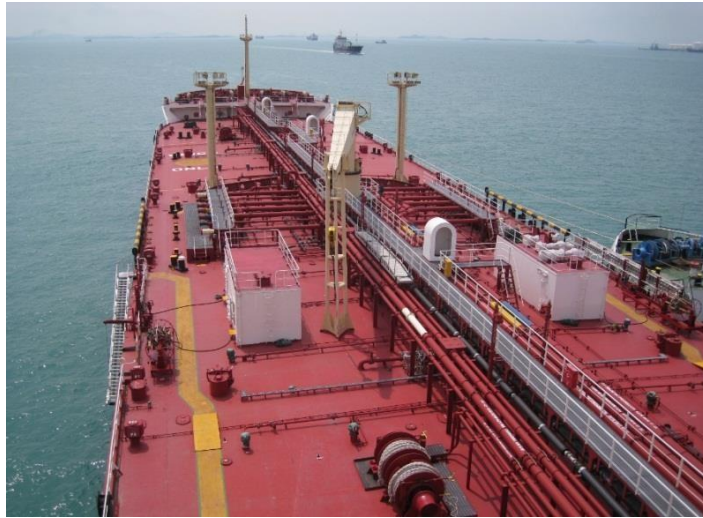
- (1) Exposed deck area is shown as follows:

Figure 4.1.3.3(1) Open deck area

- ① In general, the main deck of oil tanker adopts longitudinal frame type so that the structure within cargo areas can keep continuous and be capable of bearing the bending moment and shearing force of longitudinal strength due to cargo loading or sea action. According to the structure arrangement characteristics of oil tanker and comparison with other locations, the pulling or compressive stress of deck is the maximum under longitudinal bending moment. Meanwhile, it will also bear large loads due to green water. In addition, certain parts of main deck will bear the compressive stress caused by additional impacting and attacking in bow under severe weather conditions, and it is possible to cause the deck stability loss or dilacerations. At present, more oil tanker decks adopt HTS to reduce the scantling of structural members and weight as well as increase ship economy, however, it weakens deck rigidity and leads to stability loss.

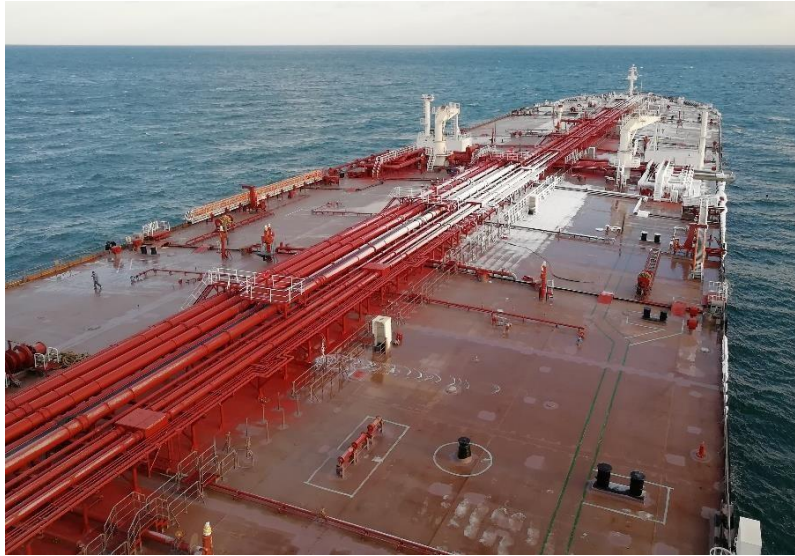
- ③ Corrosion and crack of the longitudinal members on deck are to be fully noted during survey, especially at butt welds, where leads to fracture with high risk due to improper loading or potential defects during construction. Please refer to following figure.

Figure 4.1.3.3(1)③ Open deck area

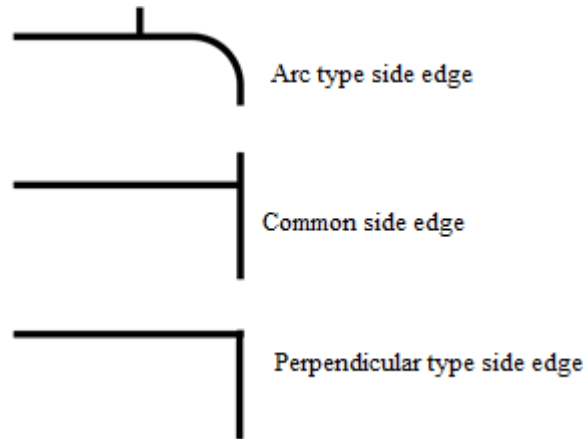
- d. There are three common section types for sheer strakes onboard the oil tankers as follows, the first is the arc-typed, with oil baffle on the arc; the second is that the sheer strake is higher than the main deck, because such type of sheer bears large loads, it is to ensure smooth and continuous so as to effectively pass the stress. If there is opening or deformation, it is possible to have severe consequence such as hull fracture or buckling. During actual service, sometimes there will be opening or cutting by mistake during repair, crew members are to strengthen inspection in these locations and take measures as early as possible. The third is that the deck side plating is connected with sheer strake in right angle, and the upper surfaces of sheer strake and plywood are parallel and level. Such type has the same requirements for stress and maintenance as the second type.

Figure 4.1.3.3(1)④d Bilge strake section type

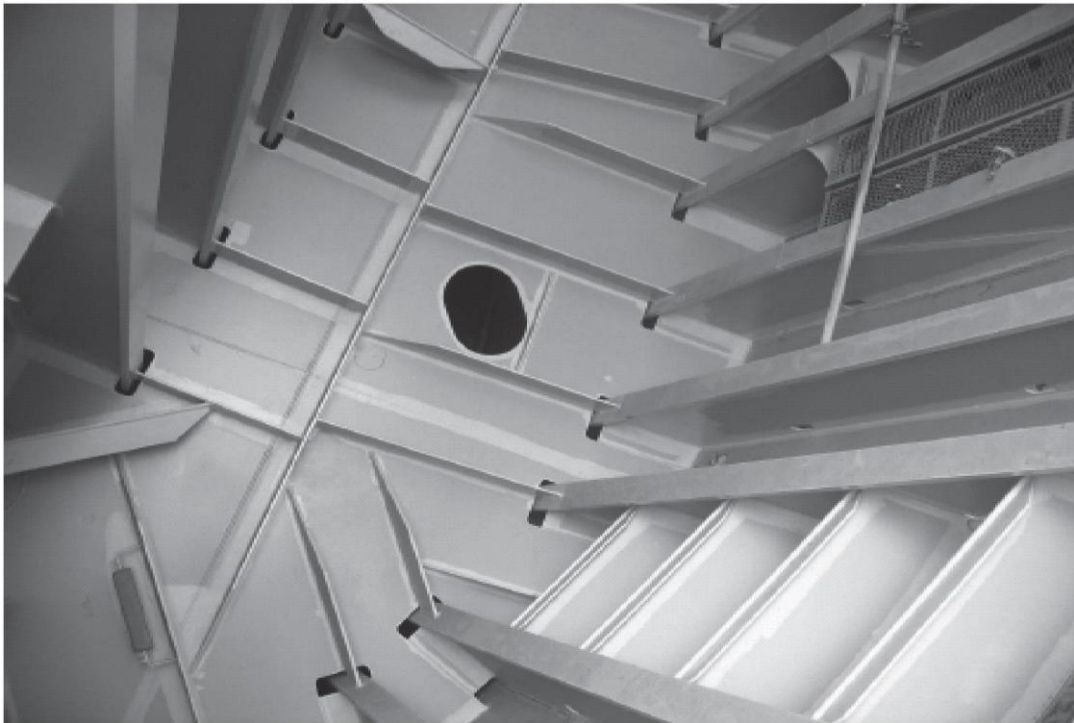
Figure 4.1.3.3(3) Bilge structure type

The inclined bottom plating at bilge is an important part of hull girder, taking part in longitudinal strength and is a supporting structure for inner bottom plating and side inner shell plating. The

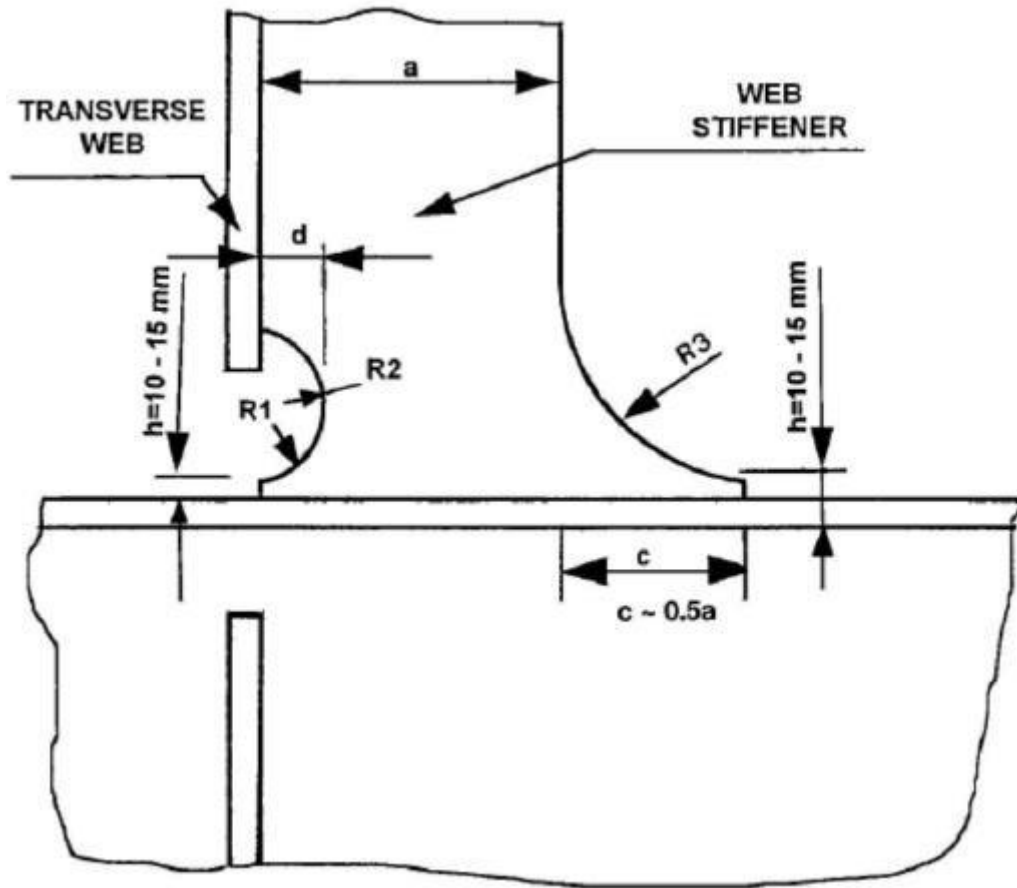
4.4.3.6 Example 4 - Technical Requirements for Web Stiffener in location of Web Frame / Side Longitudinal, as shown in the figure below:

Figure 4.4.3.6 Technical Requirements for Web Stiffener in location of Web Frame / Side Longitudinal

- (1) or a slope at toe max. 1 :3, $R1 = 1.5 \times d$ and $R3 = 1.5 \times c$
- (2) Soft toe bracket to be welded first to longitudinal
- (3) Depth 'd' of key hole notch as small as possible, max. 30 mm

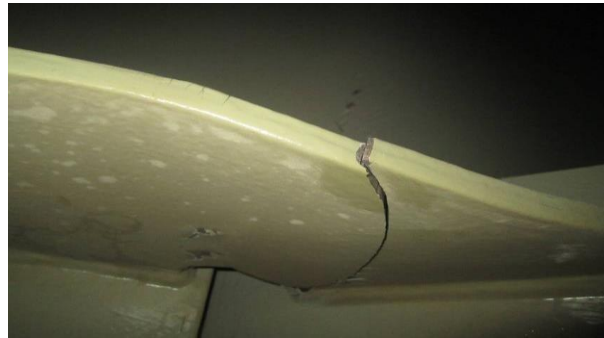
(1) The bracket at the intersection of FR99 collision bulkhead and the starboard shell longitudinal L52~L55 is deformed and cracked, as shown below:

Figure 4.4.5.1(1) Crack

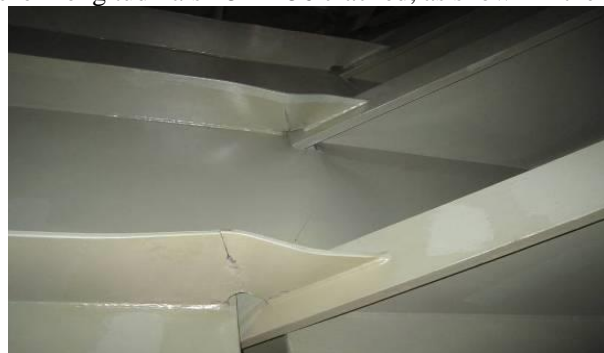
(3) FR101 transverse frame: Overall deformation of the frame web in the port and starboard side areas; the root weld of brackets and stiffeners at the intersection of the port and starboard frame web and the shell longitudinals L52~L56 cracked, as shown in the figure below:

Figure 4.4.5.1(3) Deformation

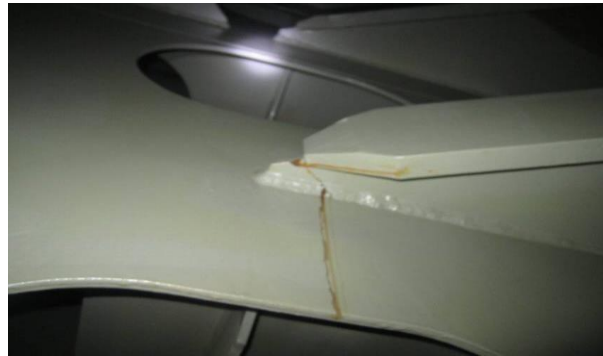
(4) FR102 transverse frame: web toe end at the intersection of the intersection of the port and

starboard shell longitudinals L53~L54 and FR102 cracked, as shown in the figure below:

Figure 4.4.5.1(4) Cracks

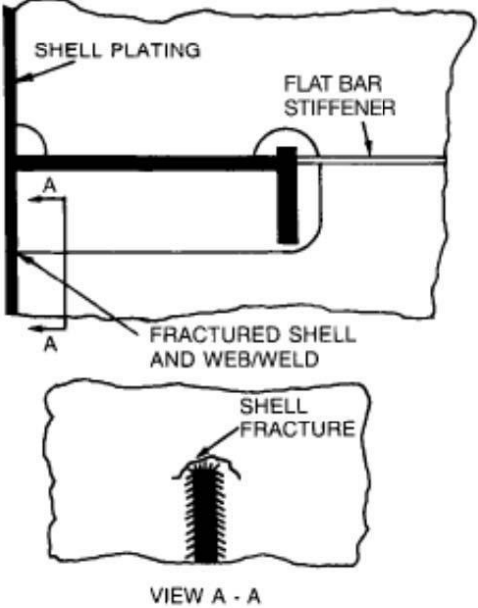
Location: Connection of longitudinals to transverse webs		No.1
Example No.2: Side shell fractures at cut-outs for longitudinal stiffener connections		
Typical Damage	Proposed Repair

<p>NOTE: FRACTURES INITIATE AT INNER SURFACE OF SHELL AND PROPAGATE THROUGH TO OUTER SURFACE</p>	<p>SHELL PLATE CROPPED AND PART RENEWED. ALTERNATIVELY WHERE FRACTURES ARE SMALL THEY MAY BE REPAIRED BY WELDING (SEE ADDITIONAL NOTES UNDER "ALTERNATIVE REPAIRS", 2.3)</p>	
<p>Factors which may have caused damage:</p> <ol style="list-style-type: none"> 1. Insufficient area of connection of longitudinal to web plates. 2. Defective weld at return around the plate thickness. 3. Localised corrosion associated with the stress concentrations in way of the longitudinal connection of web to shell. 4. Dynamic sea way loads/ship motions. 5. High shear stress in the transverse web. 	<p>Notes on repairs:</p> <ol style="list-style-type: none"> 1. Web plate cropped and partly renewed, but for small fractures, the fracture can be ground, veed-out, welded-up, and examined by NDT. 2. Collar plates to be fitted. 3. Backing brackets to be added.

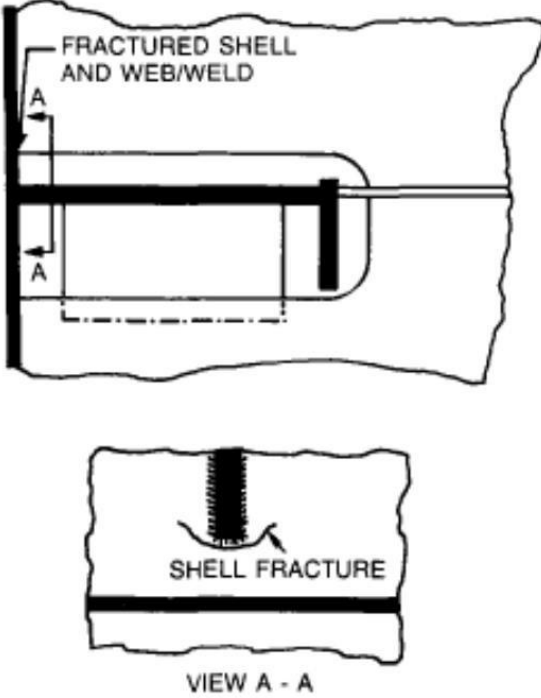
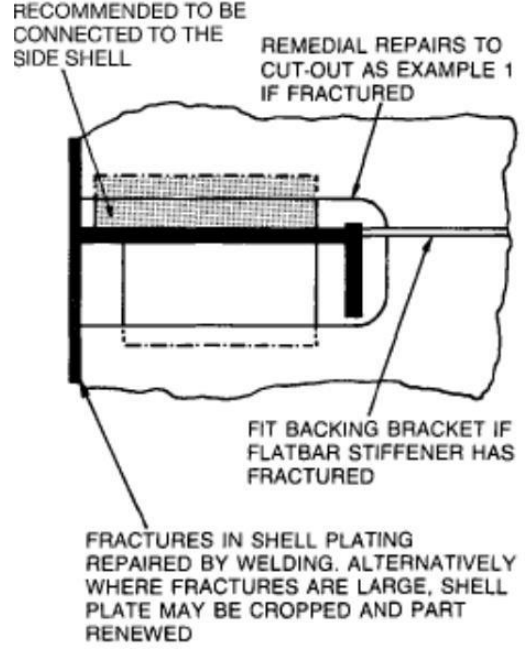
Location: Connection of longitudinals to transverse webs Example No.3: Side shell fractures due to single lug on underside		No.1
Typical Damage	Proposed Repair

<p>FRACTURED SHELL AND WEB/WELD</p> <p>VIEW A - A</p> <p>SHELL FRACTURE</p>

<p>RECOMMENDED TO BE CONNECTED TO THE SIDE SHELL</p> <p>REMEDIAL REPAIRS TO CUT-OUT AS EXAMPLE 1 IF FRACTURED</p> <p>FIT BACKING BRACKET IF FLATBAR STIFFENER HAS FRACTURED</p> <p>FRACTURES IN SHELL PLATING REPAIRED BY WELDING. ALTERNATIVELY WHERE FRACTURES ARE LARGE, SHELL PLATE MAY BE CROPPED AND PART RENEWED</p>	
<p>Factors which may have caused damage:</p> <ol style="list-style-type: none"> 1. Single lug fitted into bosom of longitudinal (instead of at the heel side) resulting in greater deflections of the longitudinal due to dynamic loads and therefore higher stress at the upper edge of the cut-out adjacent to the shell. 2. Fracture in web flat bar stiffener connection resulting in greater deflection of longitudinal. 3. Defective weld at return around the plate thickness. 4. Dynamic sea way loads/ship motions. 	<p>Notes on repairs:</p> <ol style="list-style-type: none"> 1. Web plate cropped and partly renewed, but for small fractures, the fracture can be ground, vee-out, welded-up, and examined by NDT. 2. Collar plates to be fitted. 3. Backing brackets to be added.

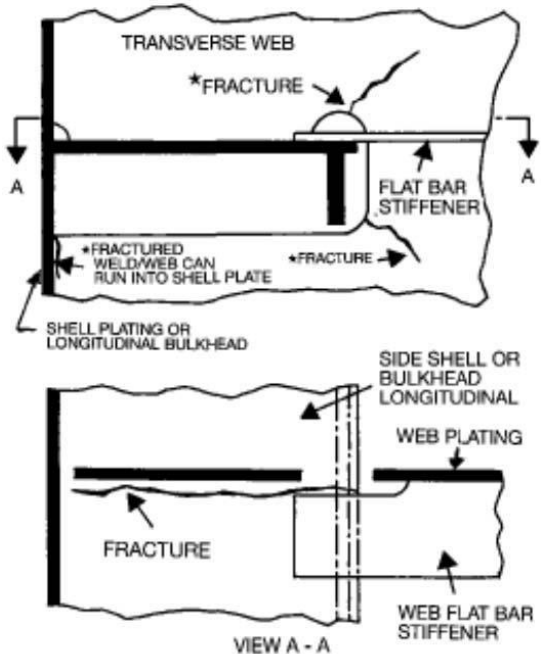
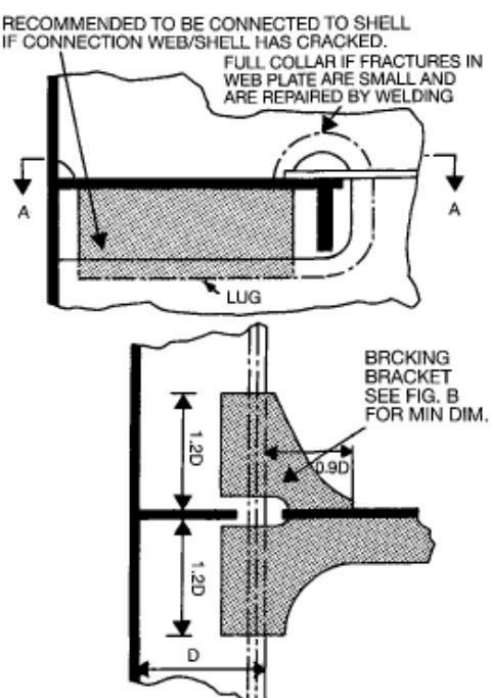
Location: Connection of longitudinals to transverse webs Example No.5: Web and longitudinal fractures. Face plate attached to underside of web. Flat bar lap welded.		No.1
Typical Damage

Factors which may have caused damage: <ol style="list-style-type: none"> 1. Asymmetrical connection of flat bar stiffener resulting in high peak stresses at the heel of the stiffener under fatigue loading. 2. Higher tensile steel longitudinal resulting in greater stresses. 3. Fabricated longitudinal with welding onto the exposed edge of the web resulting in poor fatigue strength of the connection of the longitudinal to the flat bar. 4. Insufficient area of connection of longitudinal to web plate. 5. Defective weld at return around the plate thickness. 6. High localised corrosion at areas of stress concentration, such as flat bar stiffener connection, corner of cut-out for longitudinal and connection of lug to shell at cut-outs. 7. High shear stress in the web of the transverse. 8. Dynamic sea way loads/ship motions. 	Notes on repairs: <ol style="list-style-type: none"> 1. Web plate cropped and partly renewed, but for small fractures, the fracture can be ground, veed-out, welded-up, and examined by NDT. 2. Collar plates to be fitted. 3. Backing brackets to be added.

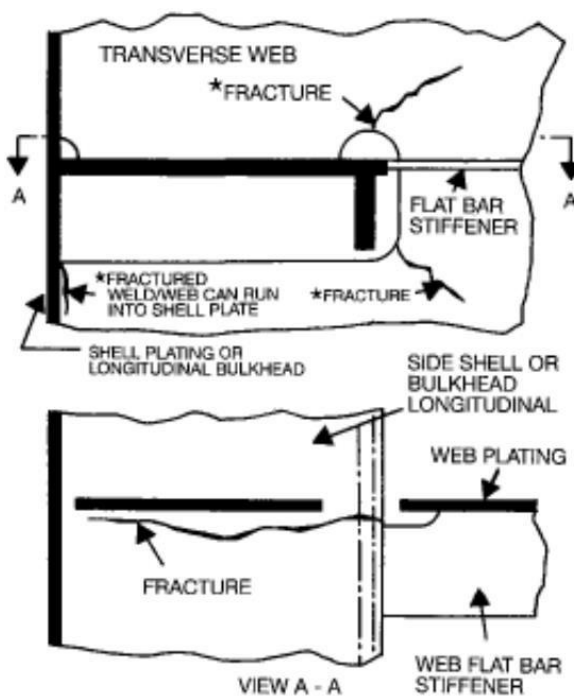
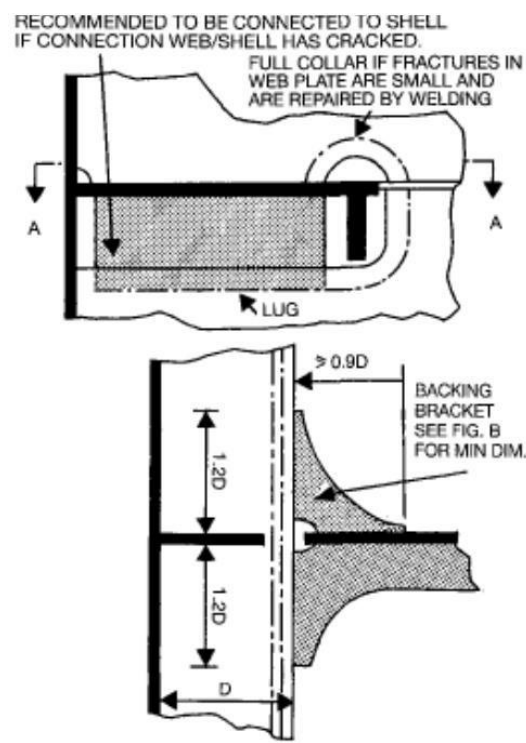
<p>Location: Connection of longitudinals to transverse webs. Example No.7: Web and longitudinal fractures. Face plate attached to underside of web. Flat bar butt welded.</p>	<p>No.1</p>
<p>Typical Damage</p>

<p>NOTE: *ONE OR MORE FRACTURES MAY OCCUR</p>	<p>Proposed Repair</p>

<p>RECOMMENDED TO BE CONNECTED TO SHELL IF CONNECTION WEB/SHELL HAS CRACKED. FULL COLLAR IF FRACTURES IN WEB PLATE ARE SMALL AND ARE REPAIRED BY WELDING</p> <p>BACKING BRACKET SEE FIG. B FOR MIN DIM.</p>
<p>Factors which may have caused damage:</p> <ol style="list-style-type: none"> 1. Asymmetrical connection of flat bar stiffener resulting in high peak stresses at the heel of the stiffener under fatigue loading. 2. Higher tensile steel longitudinal resulting in greater stresses. 3. Fabricated longitudinal with welding onto the exposed edge of the web resulting in poor fatigue strength of the connection of the longitudinal to the flat bar. 4. Insufficient area of connection of longitudinal to web plate. 5. Defective weld at return around the plate thickness. 6. High localised corrosion at areas of stress concentration, such as flat bar stiffener connection, corner of cut-out for longitudinal and connection of lug to shell at cut-outs. 7. High shear stress in the web of the transverse. 8. Dynamic sea way loads/ship motions. 	<p>Notes on repairs:</p> <ol style="list-style-type: none"> 1. Web plate cropped and partly renewed, but for small fractures, the fracture can be ground, veed-out, welded-up, and examined by NDT. 2. Collar plates to be fitted. 3. Backing brackets to be added.

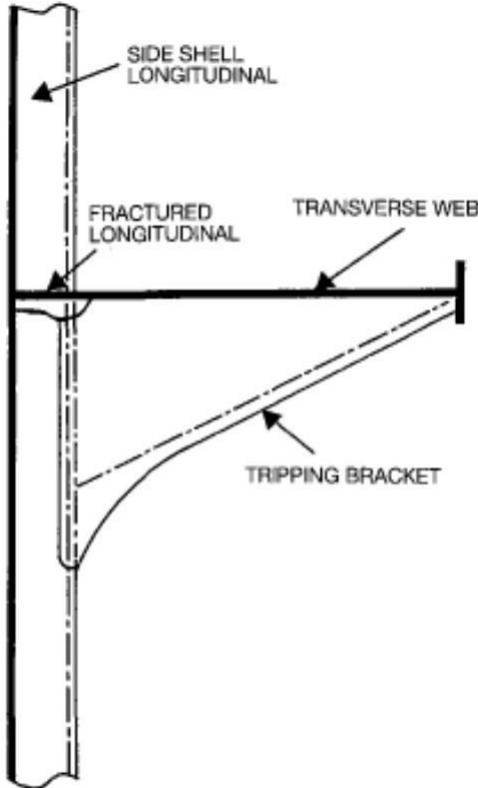
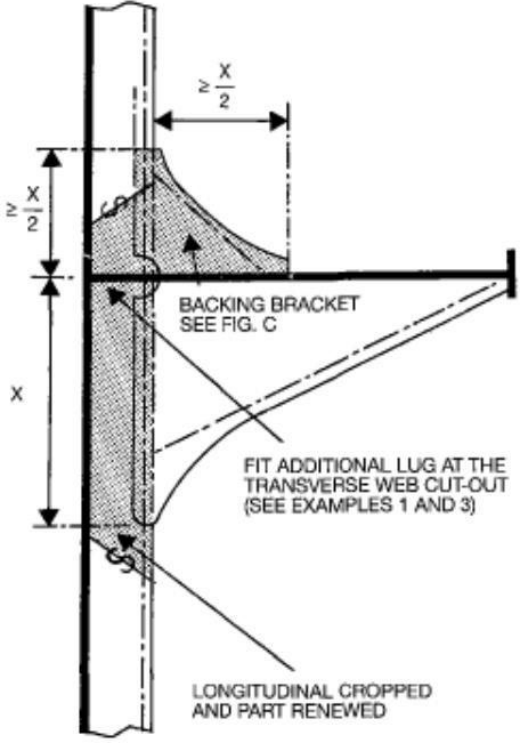
Location: Connection of longitudinals to transverse webs. Example No.8: Fractured side shell longitudinal at tripping bracket connection. No backing bracket.		No.1
Typical Damage	Proposed Repair

<p>Factors which may have caused damage:</p> <ol style="list-style-type: none"> 1. Asymmetrical connection of bracket resulting in high peak stresses at the heel of the single large bracket under fatigue loading. 2. Higher tensile steel longitudinal resulting in greater stresses. 3. Fabricated longitudinal having the face plate attached to the underside of the web (where fitted) and with welding onto the exposed edge of the web. This results in poor fatigue strength of the connection of the longitudinal web to the tripping bracket. 4. Asymmetric longitudinals resulting in additional torsional stresses. 5. Defective weld at return around the plate thickness. 6. Dynamic sea way loads/ship motion. 7. Increased stress if only a single connection is employed in way of the transverse web cut-outs. 	<p>Notes on repairs:</p> <ol style="list-style-type: none"> 1. Longitudinal to be cropped and partly renewed. 2. Backing brackets to be added. 3. Additional collar plate to be fitted at the transverse web cut-out.

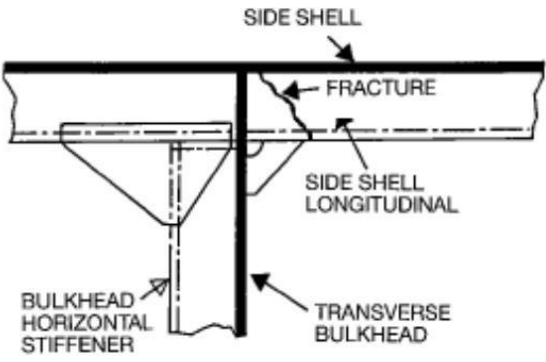
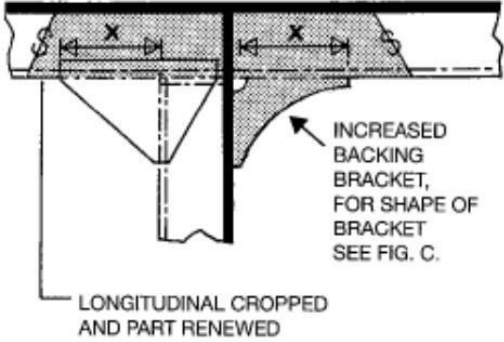
Location: Connection of longitudinals to plane transverse bulkheads. Example No.1: Fractured side shell longitudinal. Bulkhead horizontally stiffened.		No.2
Typical Damage		Proposed Repair

<p>Factors which may have caused damage:</p> <ol style="list-style-type: none"> 1. Asymmetrical connection of bracket in association with a backing bracket which is too small. This results in high stress at the toe of the smaller bracket under fatigue loading. 2. Higher tensile steel longitudinal resulting in greater stresses. 3. Dynamic sea way loads/ship motions. 4. Fabricated longitudinal having the face plate attached to the underside of the web (where fitted) and with welding onto the exposed edge of the web. This results in poor fatigue strength of the connection of the longitudinal web to the bracket. 5. Asymmetric longitudinal resulting in additional torsional stresses. 6. Horizontally stiffened transverse bulkhead causing increased end moments at the side shell longitudinal connection resulting from loading on the transverse bulkhead. 7. Deflection of the adjacent side shell transverse under load. 8. Defective weld at return around the plate thickness. 		<p>Notes on repairs:</p> <ol style="list-style-type: none"> 1. Longitudinal to be cropped and partly renewed. 2. Backing brackets to be added.

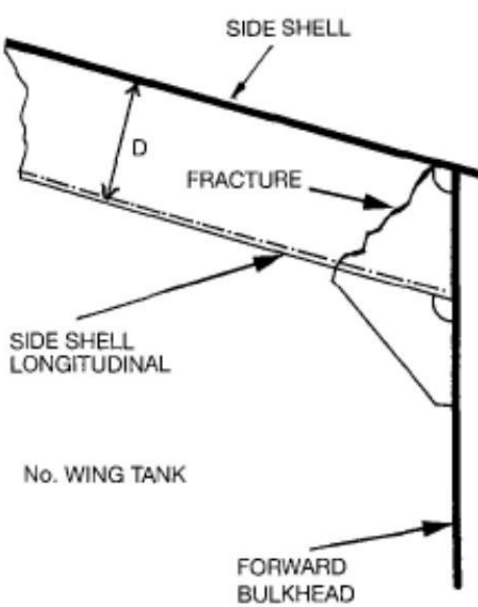
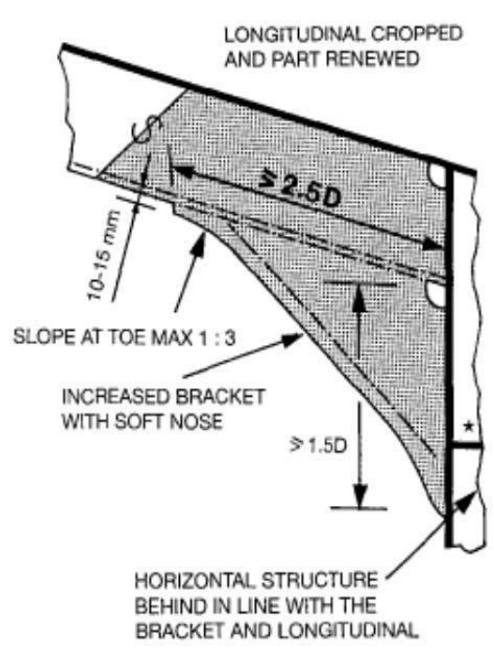
Location: Connection of longitudinals to plane transverse bulkheads		No.2
Example No.3: Fractured side shell longitudinal at forward transverse bulkhead		
Typical Damage		Proposed Repair

<p>Factors which may have caused damage:</p> <ol style="list-style-type: none"> 1. Under-designed end bracket. 2. Higher tensile steel side shell longitudinal resulting in greater stresses. 3. Fabricated longitudinal having the face plate attached to the underside of the web (where fitted) and with welding onto the exposed edge of the web. This results in poor fatigue strength of the connection of the longitudinal to the bracket. 4. Deflection of the adjacent side shell transverse under load. 5. Defective weld at return around the plate thickness. 6. Dynamic sea way loads/ship motions of forward end of ship. 		<p>Notes on repairs:</p> <ol style="list-style-type: none"> 1. Longitudinal to be cropped and partly renewed. 2. Increased bracket with soft toes.

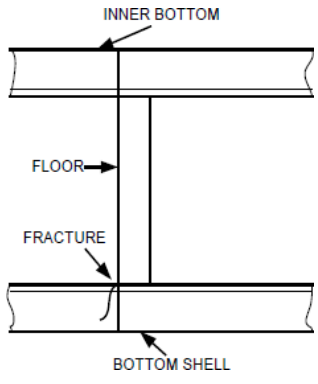
Location: Connection of longitudinals to floors in the double bottom		No.4
Example No.2: Connection of longitudinals to ordinary floors		
Typical Damage		Proposed Repair

<p>The diagram shows a cross-section of a double bottom structure. At the top is the 'INNER BOTTOM' plate. Below it is a vertical 'FLOOR' stiffener. At the bottom is the 'BOTTOM SHELL' plate. A 'FRACTURE' is indicated by a jagged line at the junction where the floor stiffener meets the bottom shell.</p>

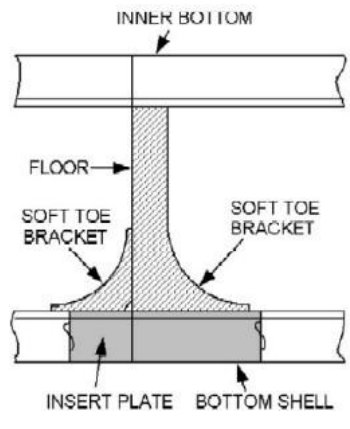
<p>The diagram shows the same cross-section as the typical damage, but with a repair. A 'SOFT TOE BRACKET' is welded to the floor stiffener and the bottom shell. An 'INSERT PLATE' is also welded to the bottom shell. The repair area is shaded to indicate the new components.</p>
<p>Factors which may have caused damage: Stress concentration at the connection of bottom longitudinal and stiffener on floor.</p>		<p>Notes on repairs: See Sketch. 1. Butt welds in bottom longitudinal should be kept clear of the soft toe bracket toes. 2. If possible soft toe bracket and vertical stiffener should be integral.</p>

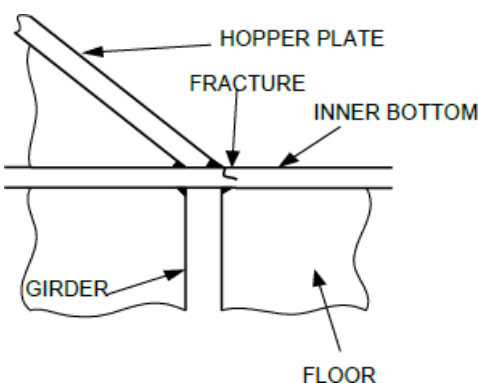
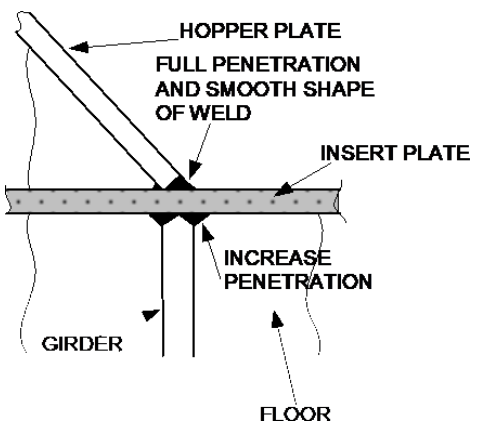
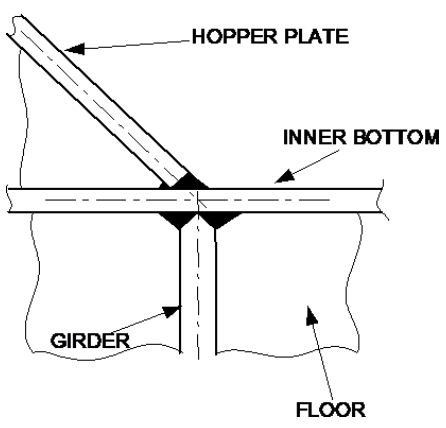
Location: Hopper and double bottom ballast tank Example No.1: Fracture on the inner bottom plating at the connection of hopper plate to inner bottom		No.5
Typical Damage	Proposed Repair

<p style="text-align: center;">NEW CONSTRUCTION</p>

Factors which may have caused damage: 1. Stress concentration at juncture of hopper plate to inner bottom. 2. Insufficient welding connection. 3. Misalignment between hopper plate, inner bottom and girder.	Notes on repairs: See Sketch.

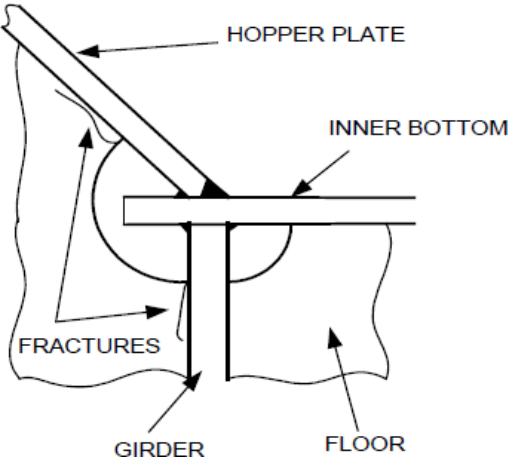
Location: Hopper and double bottom ballast tank Example No.2: Fracture at connection of bilge hopper plate and inner bottom		No.5
Typical Damage	Proposed Repair

<p>The diagram shows a cross-section of a ship's hull structure. A hopper plate is attached to a girder, which is supported by a floor. A fracture is indicated at the knuckle where the hopper plate meets the girder. Labels include: HOPPER PLATE, INNER BOTTOM, FRACTURES, GIRDER, and FLOOR.</p>

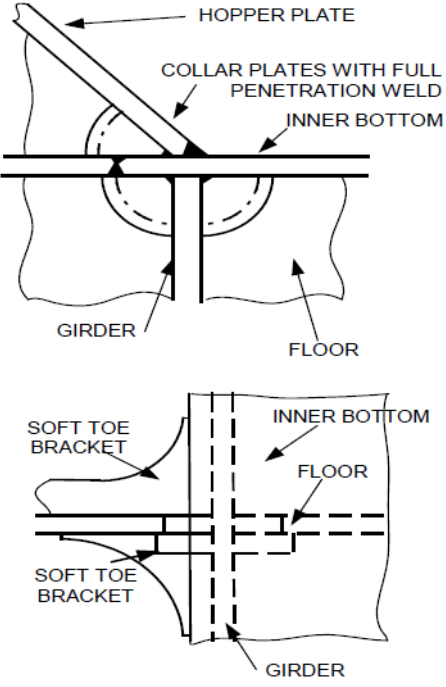
<p>The diagram shows two views of the proposed repair. The top view shows the hopper plate, girder, and floor with collar plates and full penetration welds at the connection. Labels include: HOPPER PLATE, COLLAR PLATES WITH FULL PENETRATION WELD, INNER BOTTOM, GIRDER, and FLOOR. The bottom view shows the girder and floor with soft toe brackets. Labels include: SOFT TOE BRACKET, INNER BOTTOM, FLOOR, and GIRDER.</p> <p>Notes: Plate midlines intersect</p>

Factors which may have caused damage: Stress concentration at the knuckle.	Notes on repairs: See Sketch.

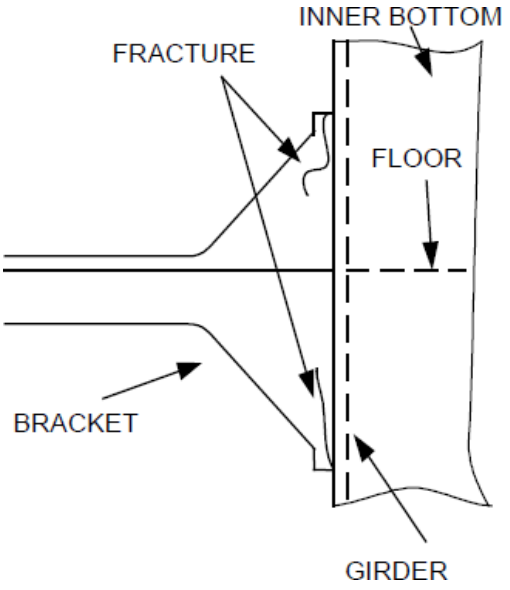
Location: Hopper and double bottom ballast tank Example No.3: Fracture in gusset plate in line with inner bottom		No.5
Typical Damage	Proposed Repair

<p>The diagram shows a cross-section of a ship's hull structure. A vertical dashed line represents the 'INNER BOTTOM'. A horizontal line represents the 'FLOOR'. A 'BRACKET' is shown connecting the inner bottom to the floor. A 'GIRDER' is shown below the floor. A 'FRACTURE' is indicated by a jagged line in the bracket. Arrows point to each component.</p>

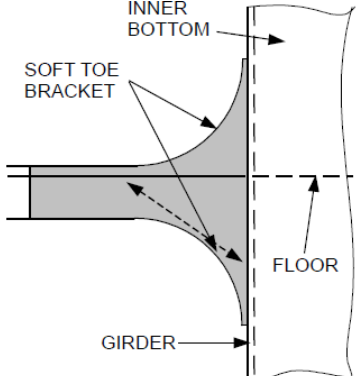
<p>The diagram shows the proposed repair. A 'SOFT TOE BRACKET' is shown with a curved transition between the 'INNER BOTTOM' and the 'FLOOR'. The 'GIRDER' is also shown. Arrows point to each component.</p> <p>Notes: Bracket radii as large as practicable. Bracket same thickness as inner bottom stiffener. Toe height should be small as possible while still allowing return weld (wrapped weld).</p>

Factors which may have caused damage: 1. Stress concentration due to small radius and abrupt toe. 2. Insufficient welding. 3. Insufficient sectional area (thickness x breadth) of the connecting bracket.	Notes on repairs: See Sketch.

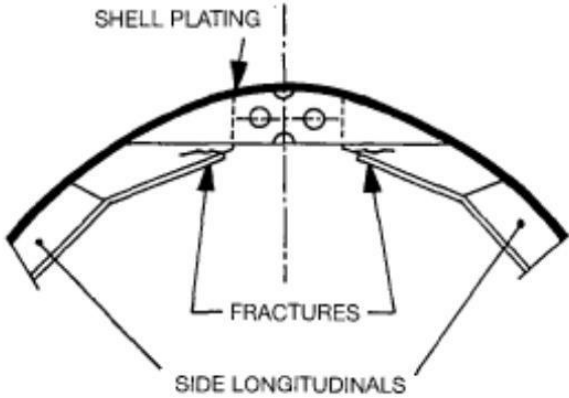
Location: Forepeak structure Example No.3: Fracture at end of longitudinal at bow structure	No.6
Typical Damage	Proposed Repair

<p>The diagram shows a cross-section of the forepeak structure. It features a curved shell plating at the top, supported by side longitudinals. Two fractures are indicated by arrows pointing to the ends of the side longitudinals where they meet the shell plating. The text 'SHELL PLATING' is at the top, 'FRACTURES' is in the middle, and 'SIDE LONGITUDINALS' is at the bottom.</p>

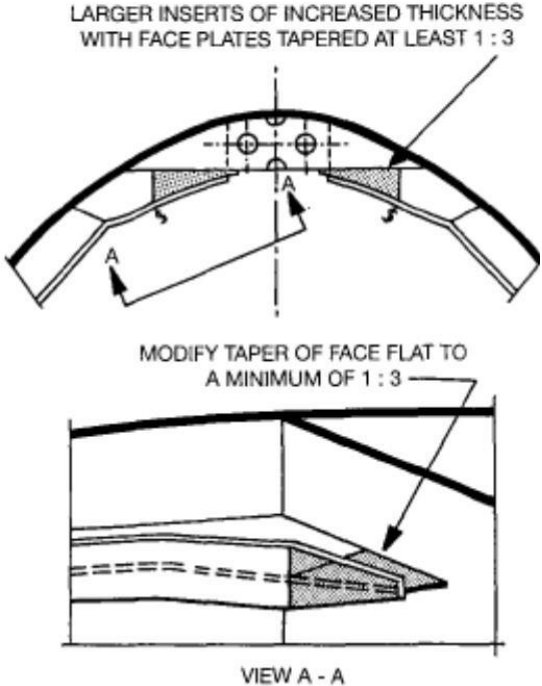
<p>The diagram illustrates the proposed repair. The top part shows a cross-section with 'LARGER INSERTS OF INCREASED THICKNESS WITH FACE PLATES TAPERED AT LEAST 1 : 3'. Below this, a section labeled 'VIEW A - A' shows a detailed view of the repair, with the text 'MODIFY TAPER OF FACE FLAT TO A MINIMUM OF 1 : 3' pointing to the tapered face plate. The repair involves inserting thicker plates with tapered face plates to reinforce the structure.</p>

Factors which may have caused damage: 1. Inadequate brackets forming the longitudinal endings at bow structure. 2. Localised thinning in way of coating failure at longitudinal endings due to flexing of the structure. 3. Dynamic seaway loadings at bow causing flexing at longitudinal endings.	Notes on repairs: 1. Modified taper of toes to a minimum of 1:3. 2. Insert web plate with increased thickness with soft toes. 3. Modified taper of face plate to a minimum of 1:3.

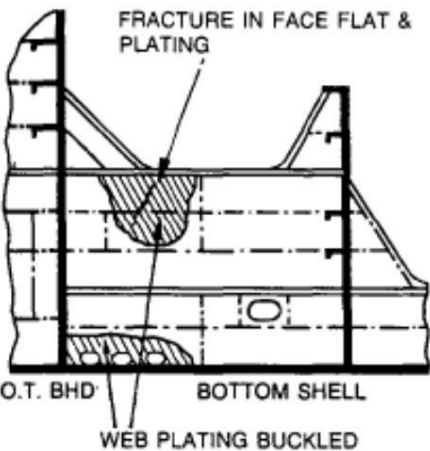
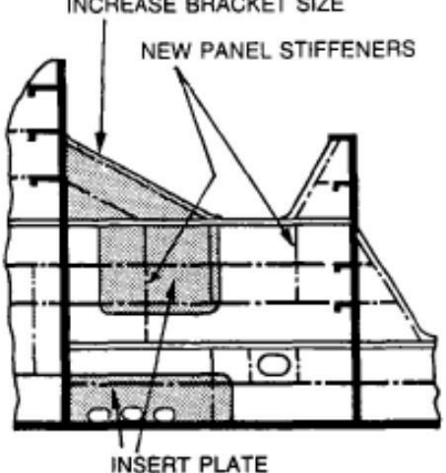
Location: Longitudinal girder end brackets		No.7
Example No.2: Fractured and buckled buttress in way of bracket connection to O.T. bulkhead.		
Typical Damage		Proposed Repair

<p>Factors which may have caused damage:</p> <ol style="list-style-type: none"> 1. Panel stiffening on girder web not fitted in way of bracket toe. 2. Stress concentration at bracket toe. 3. Local dry-docking loads. 		<p>Notes on repairs:</p> <ol style="list-style-type: none"> 1. Increased bracket size. 2. Additional panel stiffeners to be fitted.

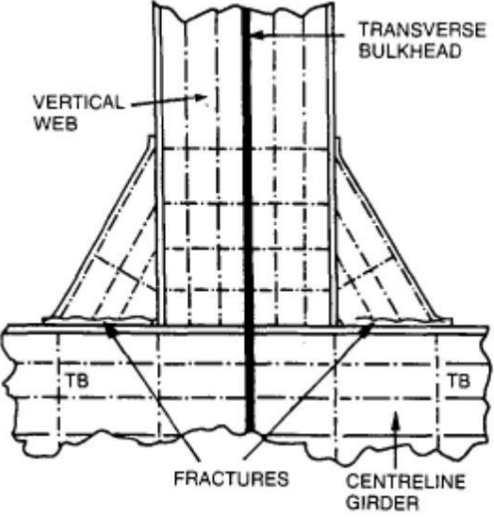
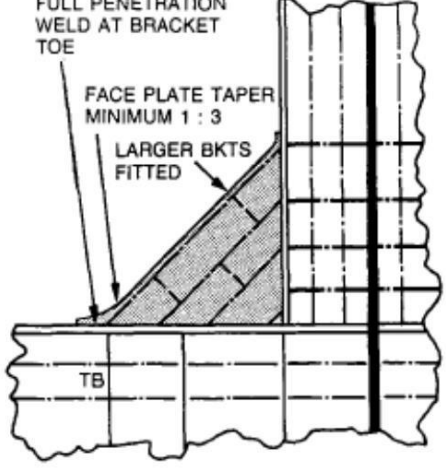
Location: Longitudinal girder end brackets		No.7
Example No.3: Fractured vertical web bracket connection to bottom centerline girder		
Typical Damage		Proposed Repair

<p>Factors which may have caused damage:</p> <ol style="list-style-type: none"> 1. Inadequate end bracket to vertical web resulting in high nominal stress. 2. Bracket toe having inadequate taper resulting in stress concentration. 3. Insufficient buckling strength of the bracket face plate. 		<p>Notes on repairs:</p> <ol style="list-style-type: none"> 1. Increased bracket size with soft toes. 2. Full penetration weld at bracket toes.

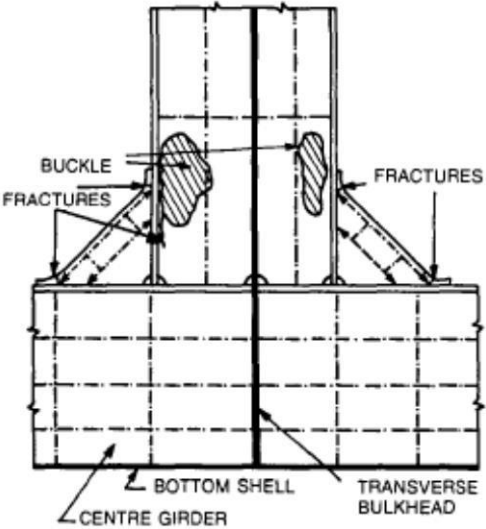
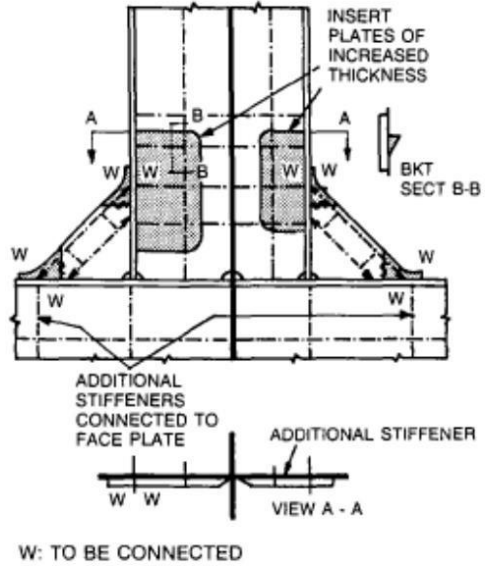
Location: Longitudinal girder end brackets		No.7
Example No.4: Buckled and fractured vertical web and bottom centre line girder bracket connection		
Typical Damage		Proposed Repair

<p>Factors which may have caused damage:</p> <ol style="list-style-type: none"> 1. Insufficient panel stiffening on vertical web. 2. Stress concentration at bracket toes with sniped face plate. 		<p>Notes on repairs:</p> <ol style="list-style-type: none"> 1. Insert web plate with increased thickness. 2. Bracket toes partly renewed. 3. Additional stiffeners connected to face plate.

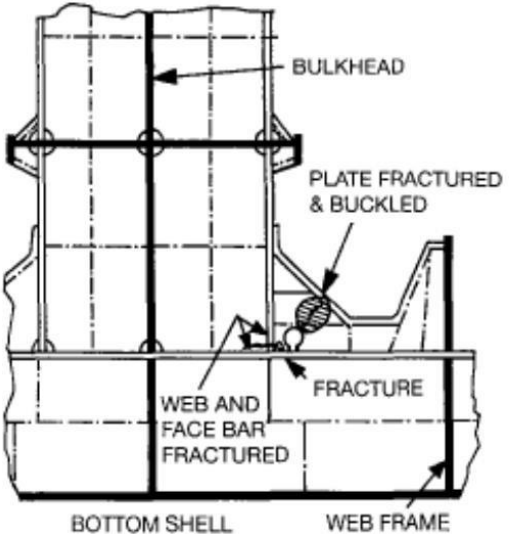
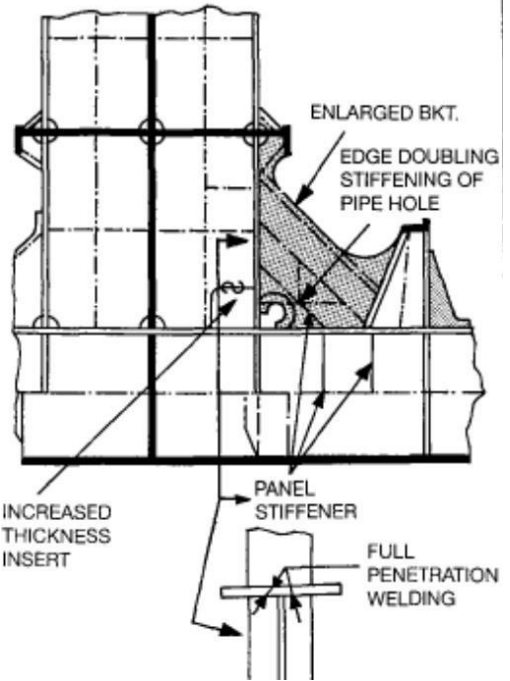
Location: Longitudinal girder end brackets		No.7
Example No.5: Fractured bottom girder brackets in way of pipe opening		
Typical Damage		Proposed Repair

<p>Factors which may have caused damage:</p> <ol style="list-style-type: none"> 1. Insufficient throat through bracket in way of pipe opening. 2. Stress concentration at pipe opening. 		<p>Notes on repairs:</p> <ol style="list-style-type: none"> 1. Enlarged bracket. 2. Additional stiffeners of bracket to be fitted. 3. Insert web plate with increased thickness/additional stiffeners 4. Full penetration weld at bracket.

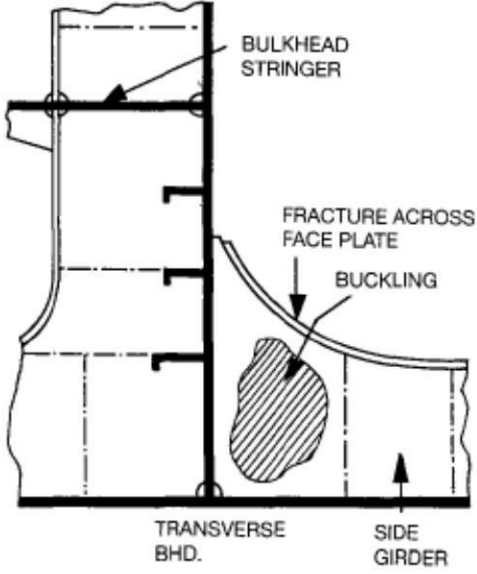
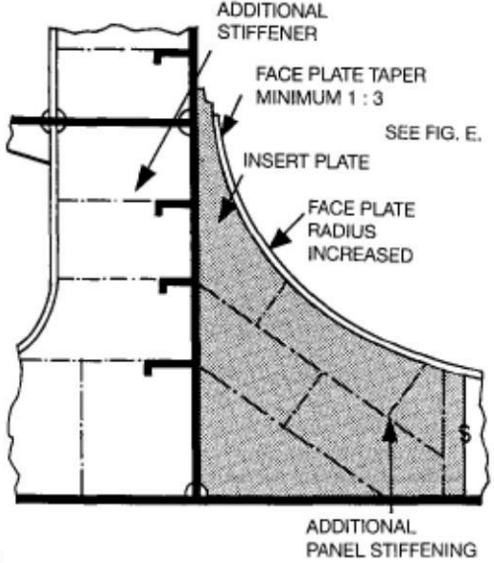
Location: Longitudinal girder end brackets		No.7
Example No.6: Fractured and buckled bottom side girder in way of end connections to O.T. bulkhead.		
Typical Damage		Proposed Repair

<p>Factors which may have caused damage:</p> <ol style="list-style-type: none"> 1. Inadequately sized bracket connection at end of girder. 2. Insufficient panel stiffening on girder web in way of end bracket. 		<p>Notes on repairs:</p> <ol style="list-style-type: none"> 1. Additional panel stiffeners to be fitted. 2. Enlarged bracket and increased face plate radius.

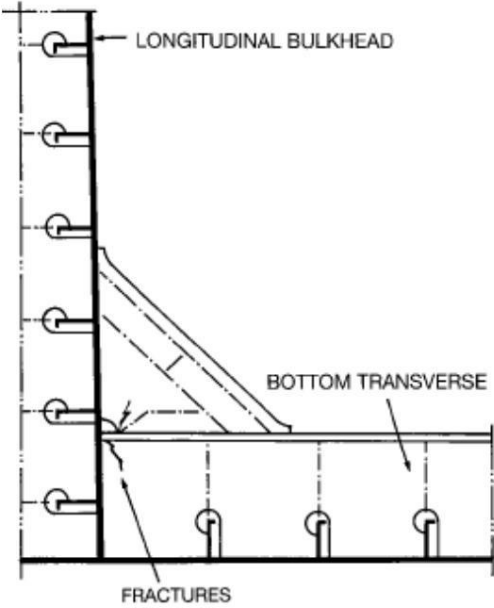
Location: Primary web, face plate end connection. Example No.2: Fractured centre tank, bottom transverse.		No.9
Typical Damage	Proposed Repair

<p>LONGITUDINAL BULKHEAD</p> <p>BOTTOM TRANSVERSE</p> <p>FRACTURES</p>

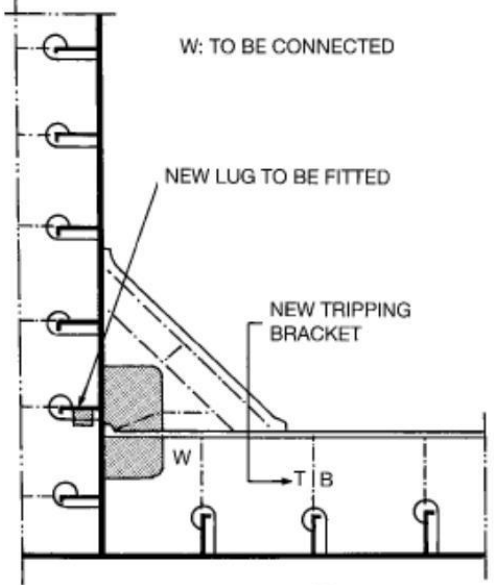
<p>W: TO BE CONNECTED</p> <p>NEW LUG TO BE FITTED</p> <p>NEW TRIPPING BRACKET</p> <p>W</p> <p>T B</p> <p>CROP AND INSERT WEB AND BRACKET IN WAY OF FRACTURE AND CONNECT ADJACENT STIFFENER TO FACE PLATE. (W). FIT TRIPPING BKT. FACE PLATE TAPER MIN. 1 : 3</p>	
Factors which may have caused damage: <ol style="list-style-type: none"> 1. Distance between longitudinal bulkhead and the bottom transverse tripping bracket too long. 2. Defective weld at the face plate taper. 3. Insufficient taper of the bottom transverse face plate. 	Notes on repairs: <ol style="list-style-type: none"> 1. Crop and insert web plate in way of fracture and connect adjacent stiffeners to face plate. 2. Additional tripping brackets to be fitted. 3. Additional collar plate to be fitted at cut-outs.

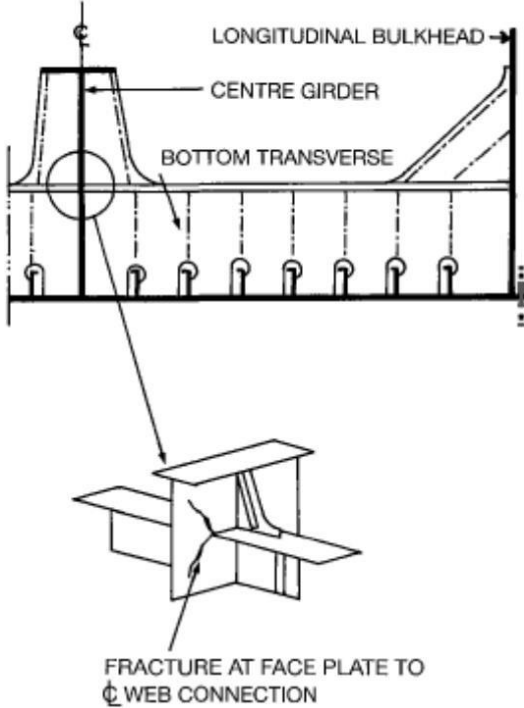
Location: Primary web, face plate end connection. Example No.3: Fractured centre girder at intersection with the bottom transverse.		No.9
Typical Damage	Proposed Repair

<p style="text-align: center;">FRACTURE AT FACE PLATE TO C WEB CONNECTION</p>

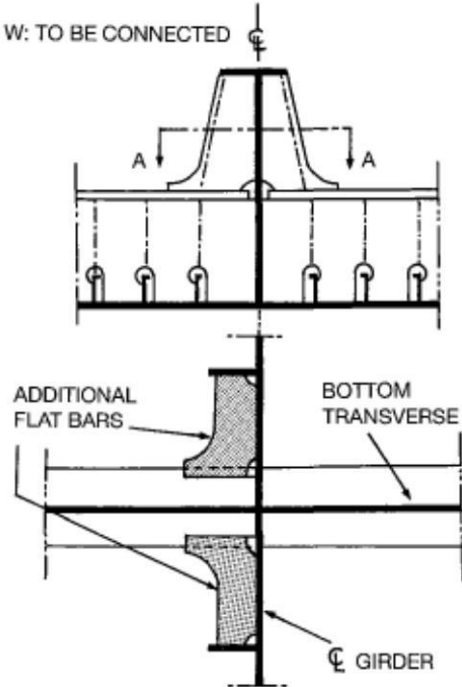
<p style="text-align: center;">ADDITIONAL FLAT BARS</p> <p style="text-align: center;">BOTTOM TRANSVERSE</p> <p style="text-align: center;">C GIRDER</p>	
Factors which may have caused damage: <ol style="list-style-type: none"> 1. Hard spot at welded connection of transverse face plate to girder web. 2. Vibration. 3. Distance from girder to tripping bracket on bottom transverse too great. 4. Misalignment of face plates. 5. Defective weld of face plate to girder web. 	Notes on repairs: Additional flat bars to be fitted and connected to face plate.
