GUIDANCE NOTES
GD 21-2019

INTERNATIONAL SHIP CLASSIFICATION

**SURVEY GUIDELINES FOR OIL
TANKERS IN SERVICE**

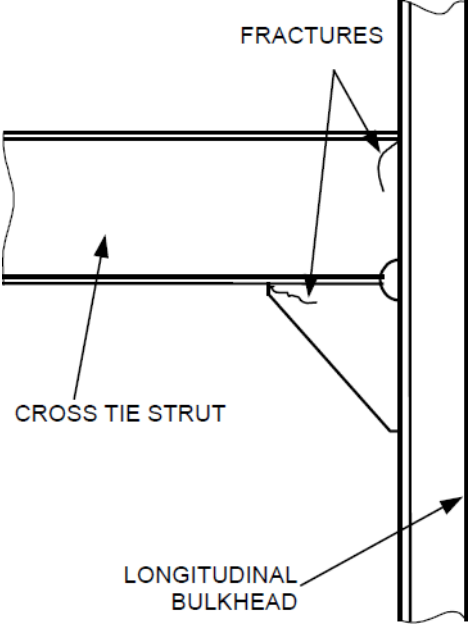
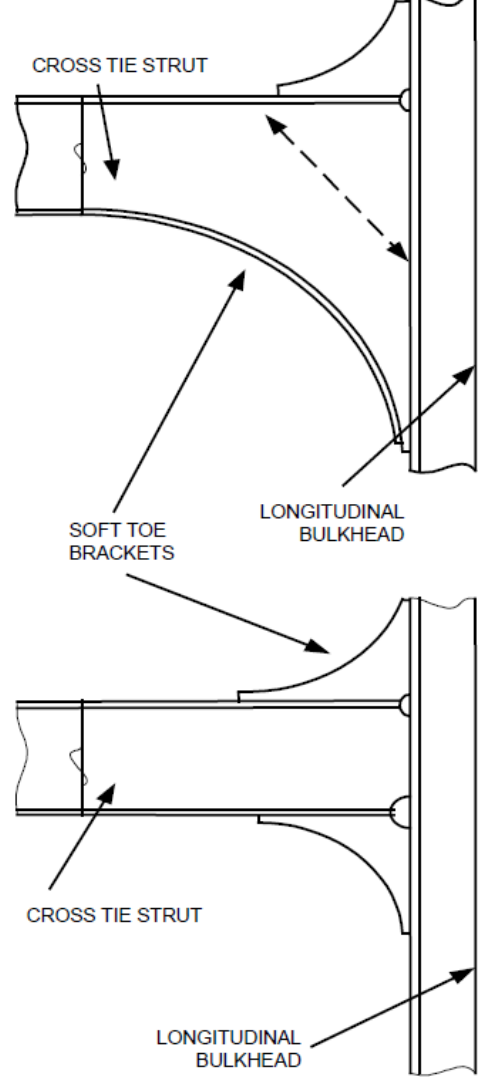
Location: Cross-ties and their end connections Example No.2: Cross ties and their end connections		No.10
Typical Damage		Proposed Repair

<p>Factors which may have caused damage:</p> <ol style="list-style-type: none"> 1. Stress concentration due to unsuitable bracket shape at juncture of cross tie to longitudinal. 2. Inadequate panel stiffening of web plate of cross-tie. 		<p>Notes on repairs: See Sketch.</p>

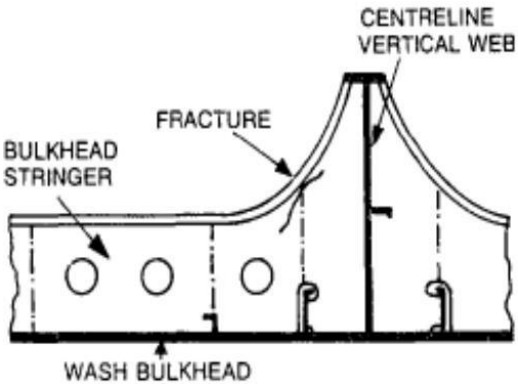
Location: Transverse bulkhead horizontal stringer Example No.2: Fractured web of stringer at the radiused bracket in way of centre line vertical web.		No.11
Typical Damage	Proposed Repair

<p>The diagram shows a cross-section of a bulkhead stringer. A horizontal stringer is attached to a vertical web. At the junction, there is a radiused bracket. A fracture is shown in the web of the stringer. The stringer has several circular openings. Below the stringer is a wash bulkhead.</p>

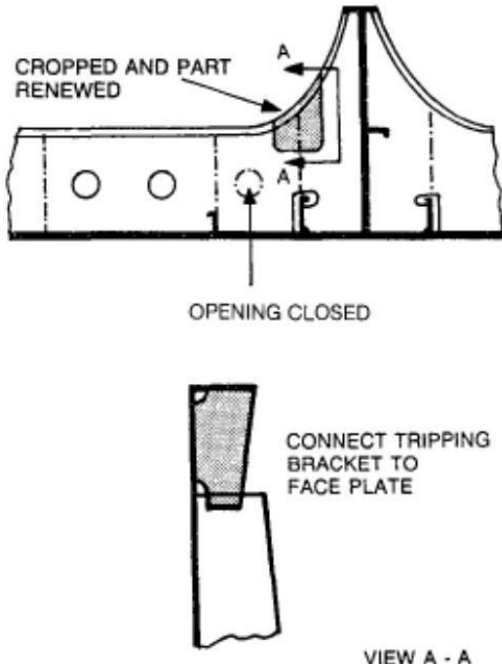
<p>The repair diagram shows the same structure as the damage diagram. The damaged web plate and face plate are shown as 'CROPPED AND PART RENEWED'. The opening is closed. A detail view 'VIEW A - A' shows a 'CONNECT TRIPPING BRACKET TO FACE PLATE'.</p>	
Factors which may have caused damage: 1. Sloshing loads where tanks are partially filled. 2. Stress concentration in the web plate due to snipe at the tripping bracket and high general stress levels in way of the radiused end bracket.	Notes on repairs: Web plate and face plate cropped and partly renewed, face plate carried around the radius and taper.

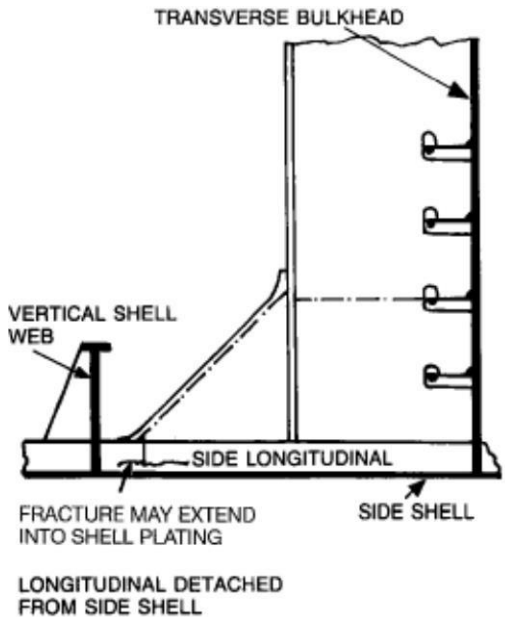
Location: Transverse bulkhead horizontal stringer		No.11
Example No.4: Fractured wing tank stringer bracket and side shell longitudinal in way		
Typical Damage		Proposed Repair

<p>TRANSVERSE BULKHEAD</p> <p>VERTICAL SHELL WEB</p> <p>SIDE LONGITUDINAL</p> <p>SIDE SHELL</p> <p>FRACTURE MAY EXTEND INTO SHELL PLATING</p> <p>LONGITUDINAL DETACHED FROM SIDE SHELL</p>

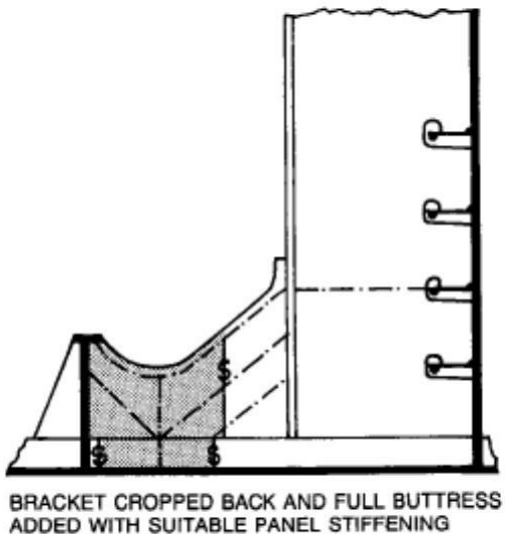
<p>BRACKET CROPPED BACK AND FULL BUTTRESS ADDED WITH SUITABLE PANEL STIFFENING</p>
<p>Factors which may have caused damage:</p> <ol style="list-style-type: none"> 1. Bad design of stringer connection to web frame with inadequate buttress size to absorb stringer end loads. This results in high stresses in the side shell longitudinal. This is the major contributory factor with the design illustrated. 2. Stress concentration in the web of bracket where face bar is sniped. 3. Dynamic loads on the bulkhead and side shell. 4. Localised corrosion of bracket toe at area of stress concentration. 		<p>Notes on repairs:</p> <ol style="list-style-type: none"> 1. Bracket cropped and partly renewed, and modified the Bkts to U type. 2. Added with suitable panel stiffeners.

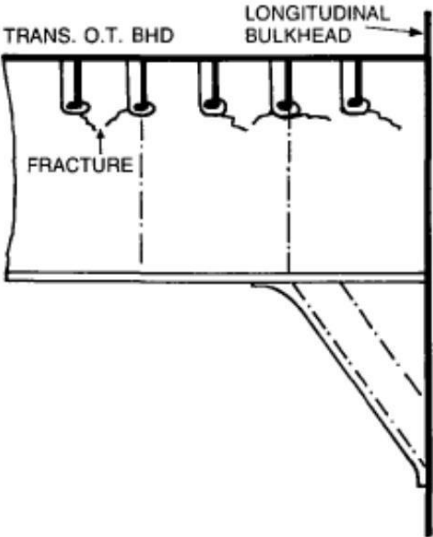
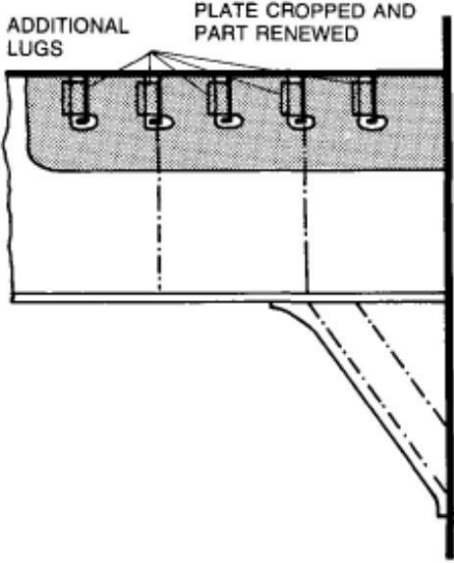
Location: Transverse bulkhead stiffener/primary web intersection Example No.1: Fractured web at cut-outs for vertical stiffeners.		No.12
Typical Damage		Proposed Repair

<p>Factors which may have caused damage:</p> <ol style="list-style-type: none"> 1. Dynamic internal loads in full tanks due to ship motion. 2. High peak stresses in way of cut-out corners. 3. Insufficient area of connection for vertical stiffener. 4. Localised corrosion at areas of stress concentration. 5. High shear stress in the horizontal stringer web plate. 		<p>Notes on repairs:</p> <ol style="list-style-type: none"> 1. Web plate to be cropped and partly renewed. 2. Additional collar plates to be fitted at cut-outs.

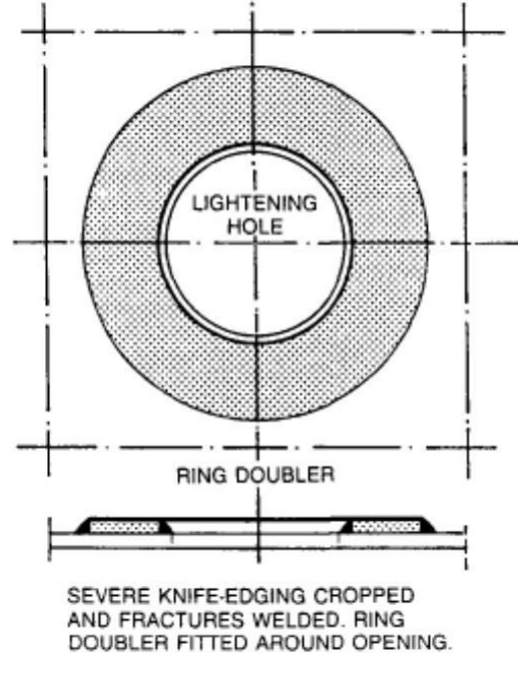
<p>LIGHTENING HOLE</p> <p>RING DOUBLER</p> <p>SEVERE KNIFE-EDGING CROPPED AND FRACTURES WELDED. RING DOUBLER FITTED AROUND OPENING.</p>
<p>Factors which may have caused damage:</p> <ol style="list-style-type: none"> 1. Corrosion losses causing thinning and knife-edging of plating surrounding holes. 2. Lack of material associated with too many holes close together leading to stress concentrations. 		<p>Notes on repairs:</p> <p>Severe knife-edging plate to be cropped, fractures to be repaired by weld, and ring doublers to be fitted around opening.</p>

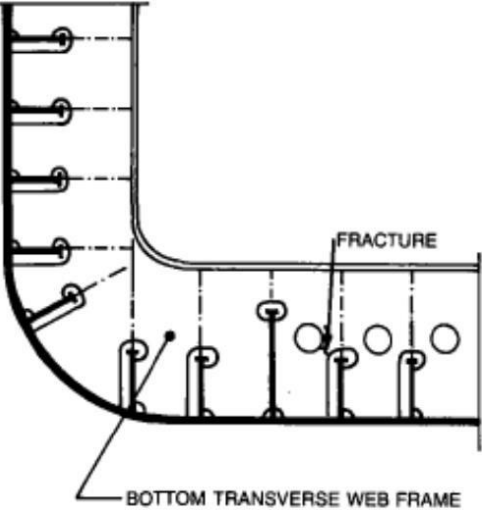
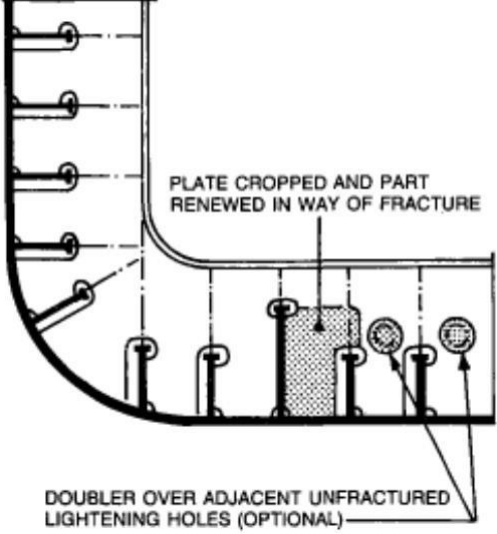
Location: Lightening holes and openings in primary webs and swash bulkheads Example No.3: Fractured web of bottom transverse in way of lightening holes		No.13
Typical Damage		Proposed Repair

<p>Factors which may have caused damage:</p> <ol style="list-style-type: none"> 1. Unstiffened lightening holes too close to longitudinal cutouts causing stress concentrations in web plating. 2. Corrosion losses on edges of openings. 		<p>Notes on repairs:</p> <ol style="list-style-type: none"> 1. Web plate cropped and partly renewed in way of fracture. 2. Double plate to be fitted over adjacent lighting hole.

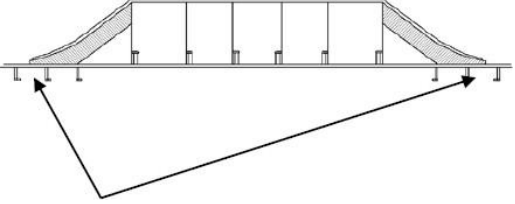
Location: Deck Structure Example No.1: Fracture at ends of deck transverse		No.14
Typical Damage		Proposed Repair

<p>Factors which may have caused damage: High stress due to toes bracket ending at cut out for longitudinal.</p>		<p>Notes on repairs: See Sketch. 1. Increase bracket length to end between underdeck longitudinals and align end to underdeck transverse. 2. Install fitted collar rather than lapped collar. 3. Insert deck plating if fracture extends into deck.</p>

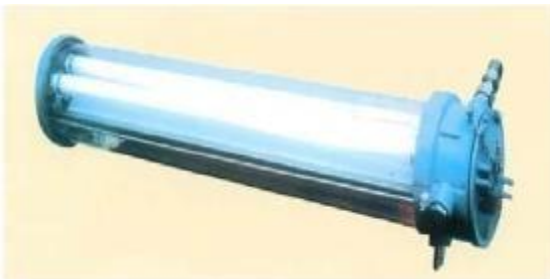
Figure 5.5.3.1(1)(3) Explosionproof fluorescent lamp

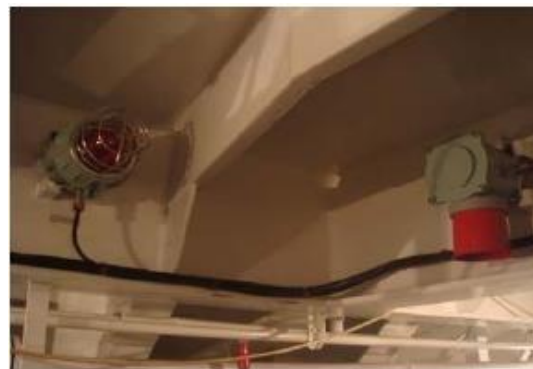
Figure 5.5.3.1(1)(4)
Explosionproof lamp and explosionproof motor

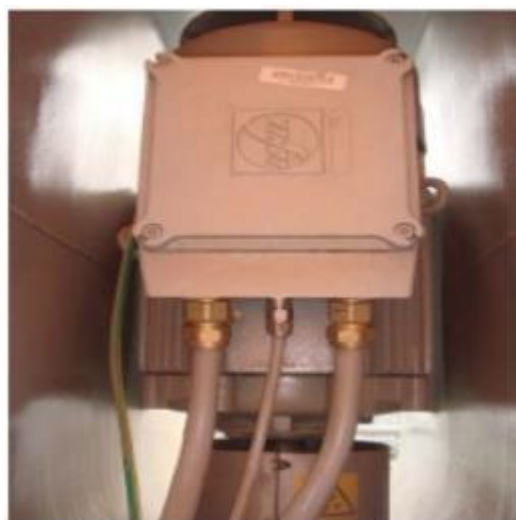
Figure 5.5.3.1(1)(5) Explosionproof electrode

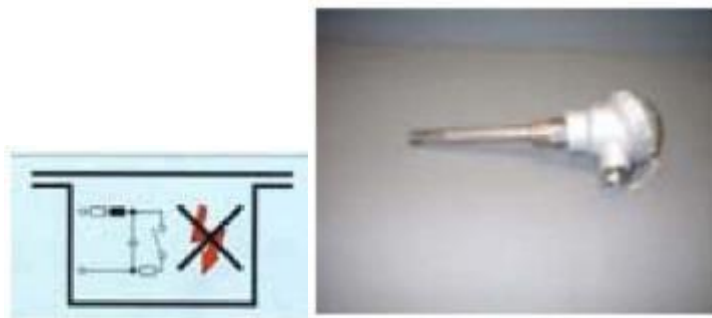
(3) Intrinsically safe (Exia;ib): the circuit or a part of the circuit in which any electric arc or thermal effect produced in the specified test conditions, which includes normal operation such as opening and closing and fault conditions such as short circuit or earthing, is not capable of causing ignition of specified inflammable gas or vapour. PT-100 temperature sensors are commonly used intrinsically safe equipment. See the figure below.

Figure 5.5.3.1(3)① Intrinsically safe and PT-100 temperature sensor

① Work principle of PT-100: temperature is the physical parameter that represents cold and hot engineering of an object, it microscopically reflects intensity of thermal motion of molecule inside object or the average kinetic energy. At present, temperature sensors usually adopt platinum resistance of standard 4 wire to measure temperature. The measurement is based on the characteristics that the resistance value of platinum conductor increases with temperature;

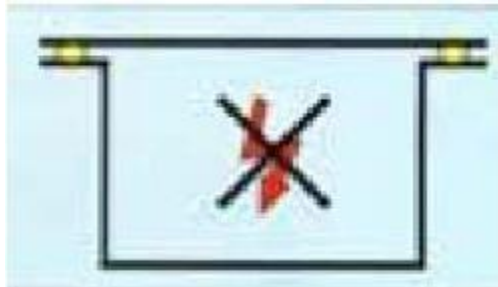
(6) Increased safety type (Exe): a type of protection applied to general industrial electrical apparatus in which additional measures are applied so as to give increased security against the possibility of excessive heat and occurrence of arcs and sparks under normal operation condition.

Figure 5.5.3.1(6) Increased safety type (Exe)

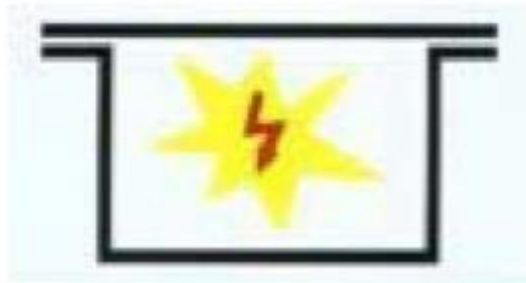
(7) Sintered flame arrestor: an explosionproof enclosure, made by atomic sintering procedure, external flammable gas can penetrate into the enclosure and cause combustion and explosion inside, however, the generated energy is insufficient to detonate the external flammable gas. It is mainly used for flammable gas detection.

Figure 5.5.3.1(7) Sintered flame arrestor

The sintered metal oxide inductor is substantially polycrystalline multiphase structure similar to ceramic structure. After sintering, lattice defects are produced, cation distribution is in a non-equilibrium state, despite aging, such non-equilibrium state is not completely eliminated. For long-term use, the unstable non-equilibrium state is slowly transformed to stable equilibrium, the crystal size, pore diameter and depth, grain boundary barrier, etc. will be changed, causing drift phenomena of gas-sensitive characteristics, i.e. detection sensitivity is reduced.

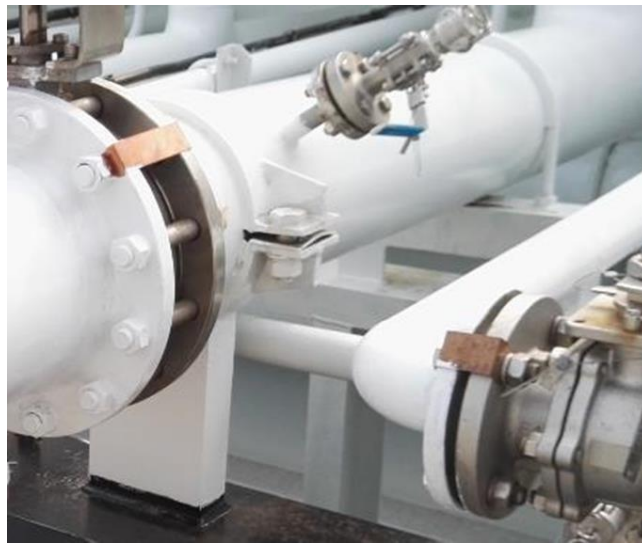
- (1) The metal casings of all electrical equipment in any hazardous zones or spaces are to be reliably earthed.
- (2) All cargo piping and inert gas lines and ventilation ducts are to ensure continuous electrical connection with the hull. Copper/white steel sheets between flanges or bonding gasket below connecting bolts can be used, or it can be ensured that bolt connection can guarantee continuous electrical connection.
- (3) All tanks are to ensure reliable electrical earthing of relevant processing unit with hull.
- (4) The fans are to be of non-sparking type, and when air and fire dampers are closed/open, no spark will occur (non-ferrous metal/other gaskets are generally used at points of contact).
- (5) Reliable electrical connection with hull is to be ensured during rigging replacement.

Figure 5.5.3.2 Pipe connection against static electricity

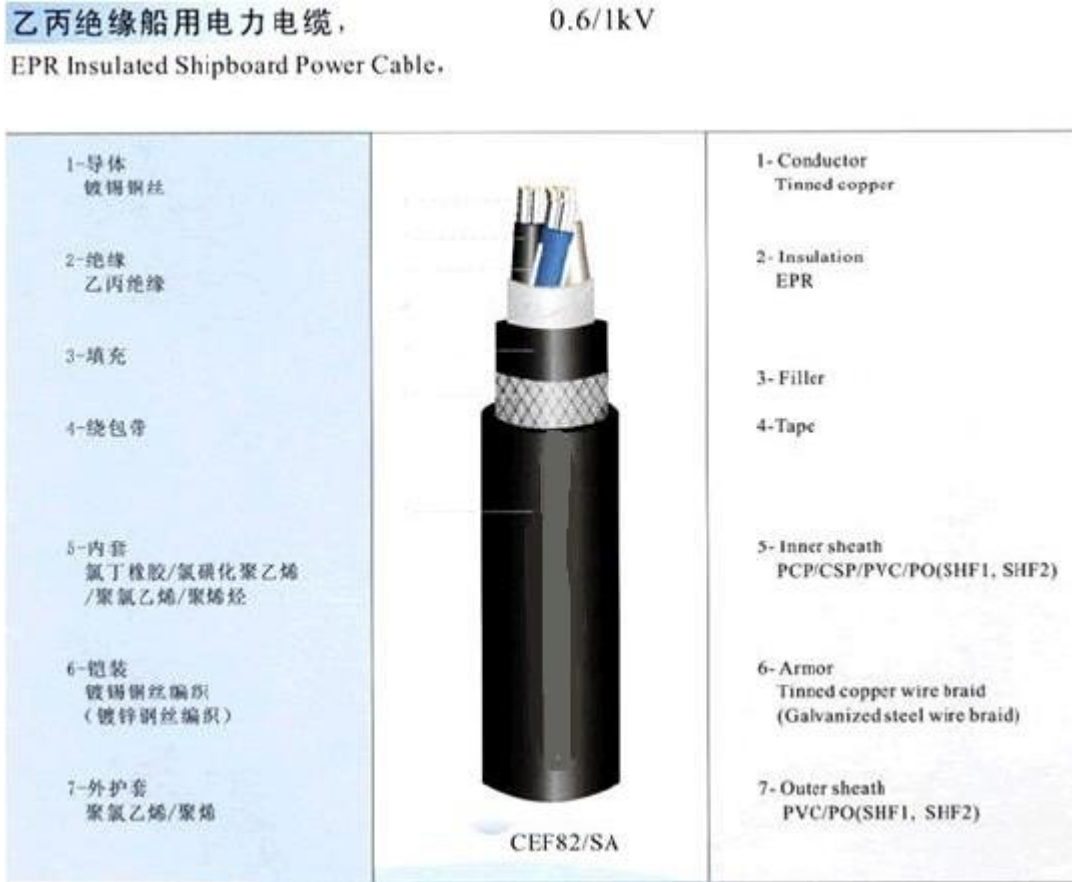
Cables laid outdoor are generally with impervious sheath, as shown below

Figure 5.5.3.3(1) B-C insulated marine power cable

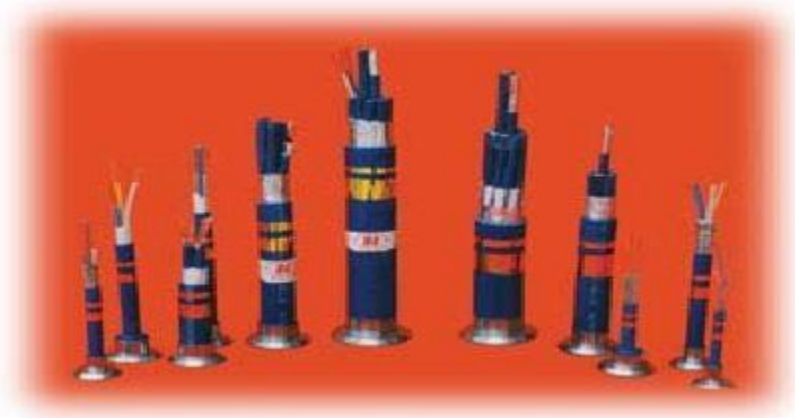
In addition to characteristics of low capacitance and low inductance, strengthening shield is also adopted so that cables have excellent shielding properties and strong resistance to external electromagnetic interference, radio frequency interference and electric coupling, thus can be used as transmission cable to transit weak signal in intrinsically safe circuits of distribution and control systems and automatic detection control systems (with rated voltage of 450/750) of industrial sectors in explosive atmospheres such as chemical and petroleum.

Figure 5.5.3.3(2) Intrinsically safe cable

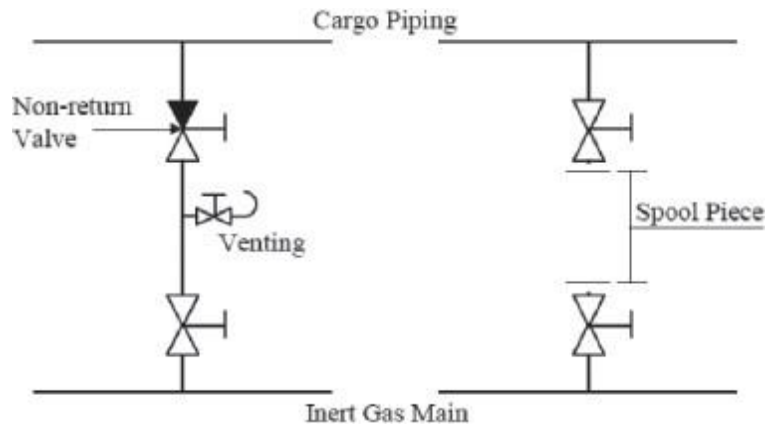
5.7.3 IGS system and cargo oil pipe arrangement are as follows:

Figure 5.7.3 IGS system and cargo oil pipe arrangement

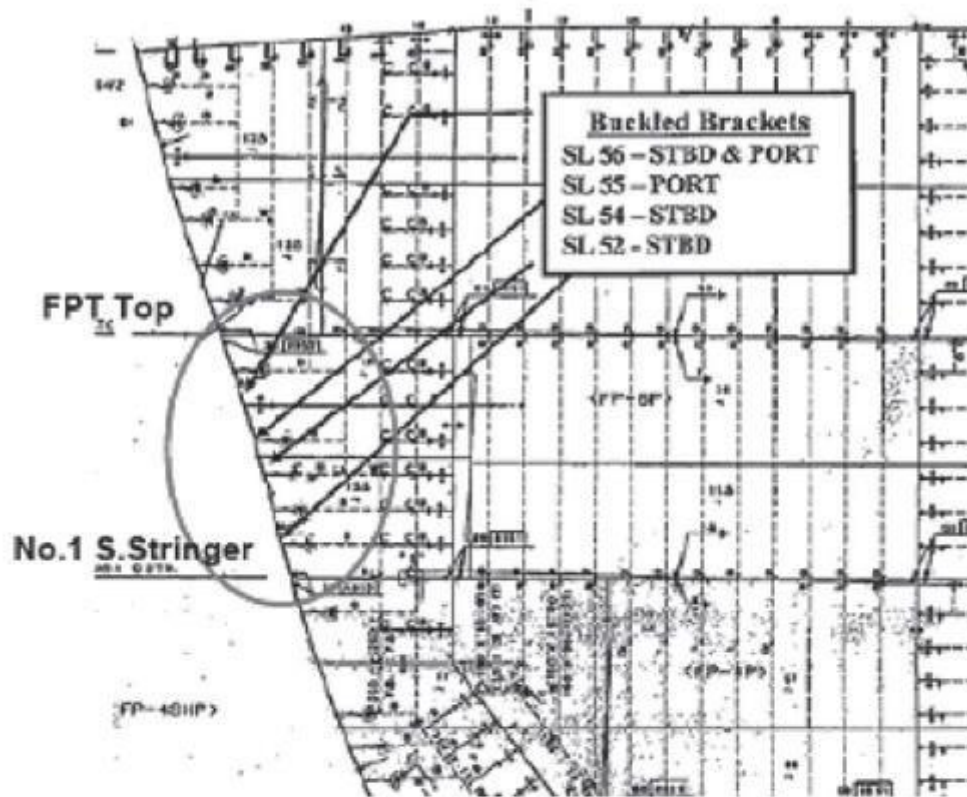
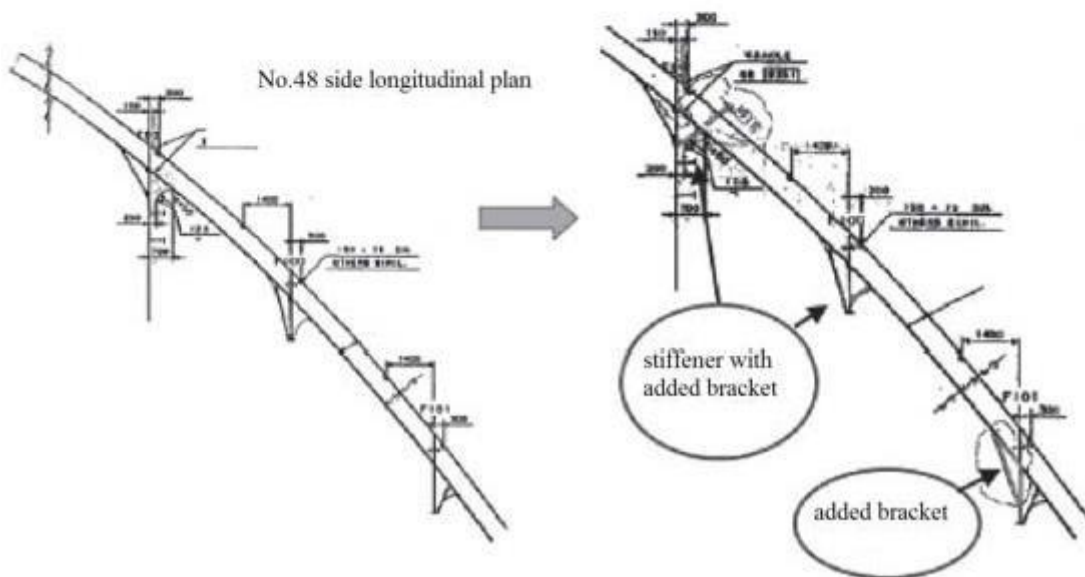
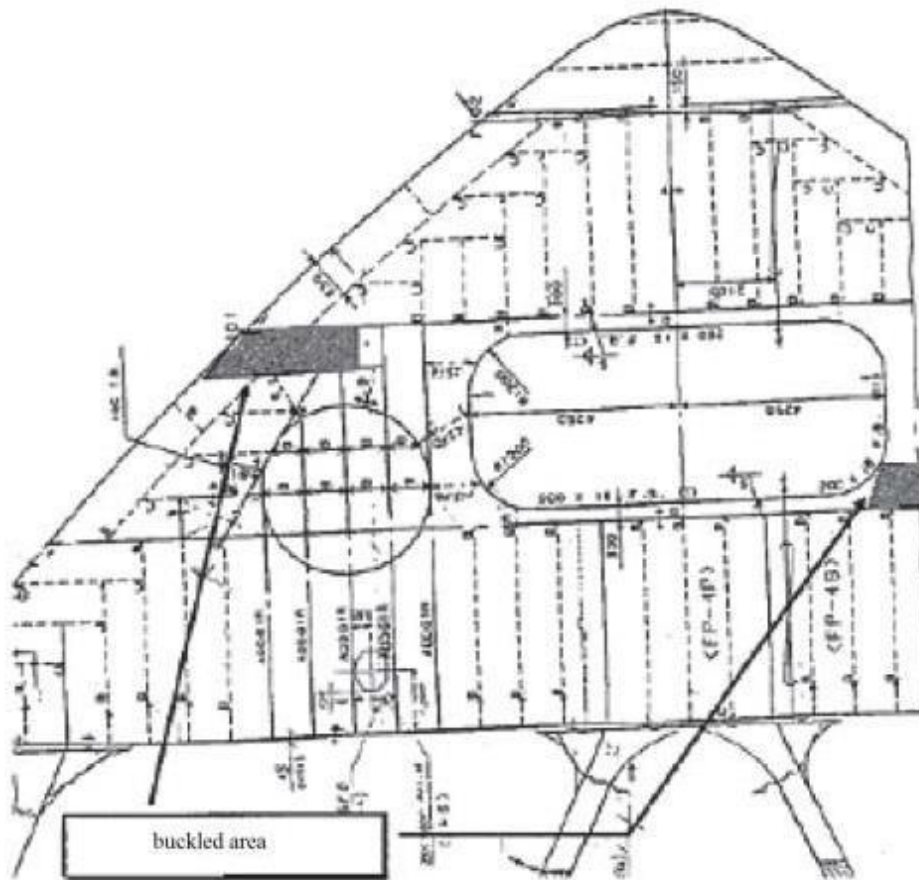
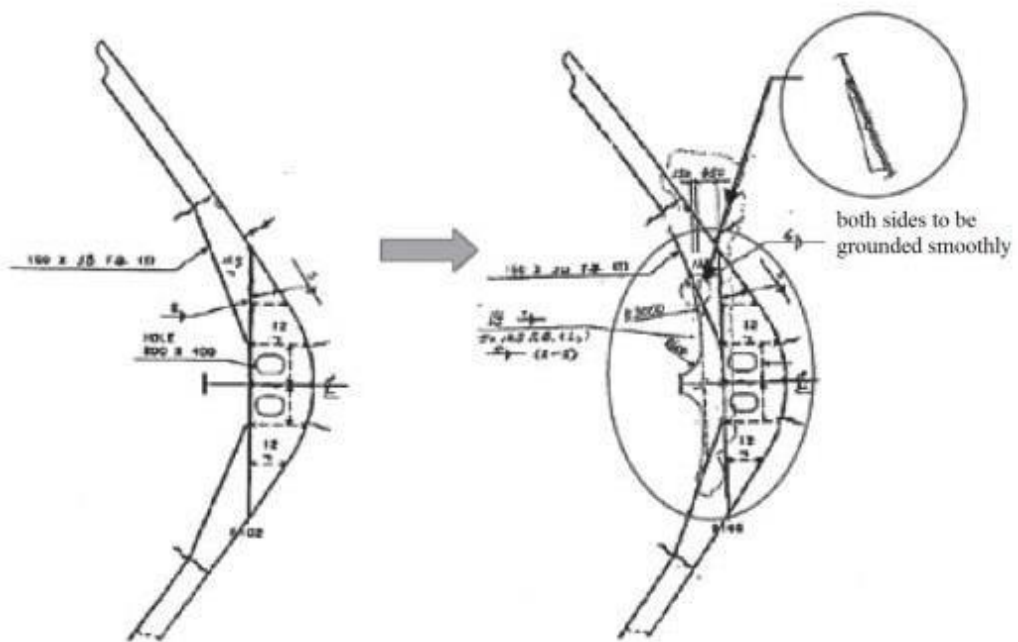
7. Key structural area of bow structure (Above lightload waterline to freeboard deck)
